# Eastern Sandoval County Arroyo Flood Control Authority

INTERIM PRELIMINARY NEEDS ASSESSMENT

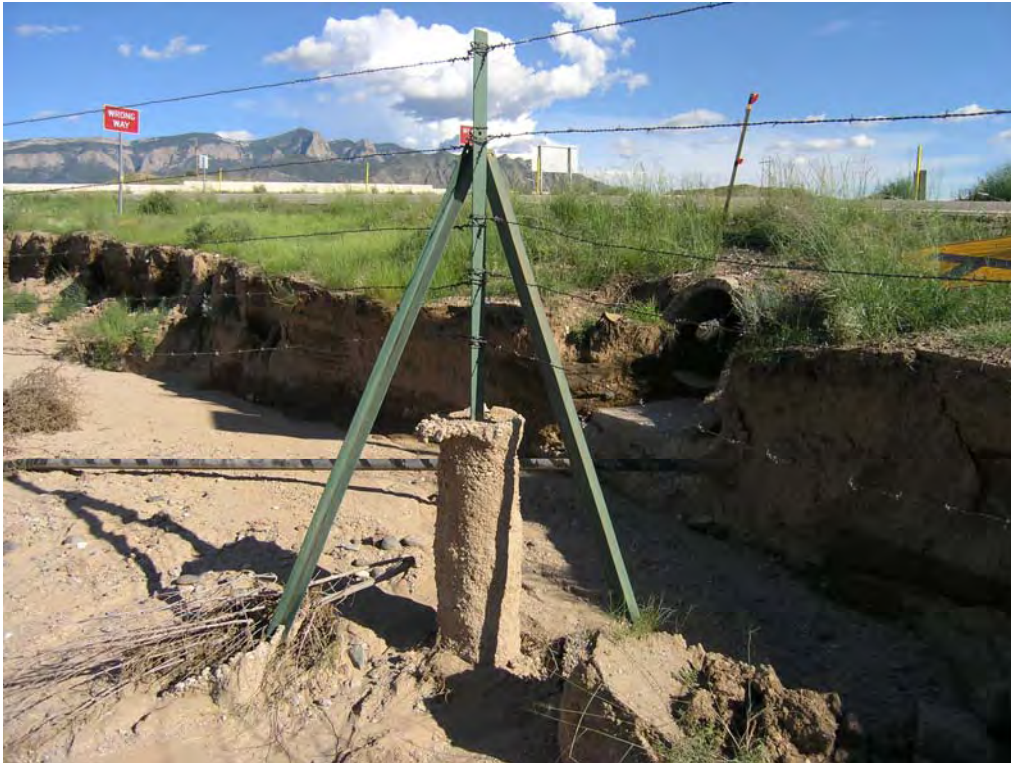
**Ongoing erosion conditions at I-25 and Avenida Bernalillo**

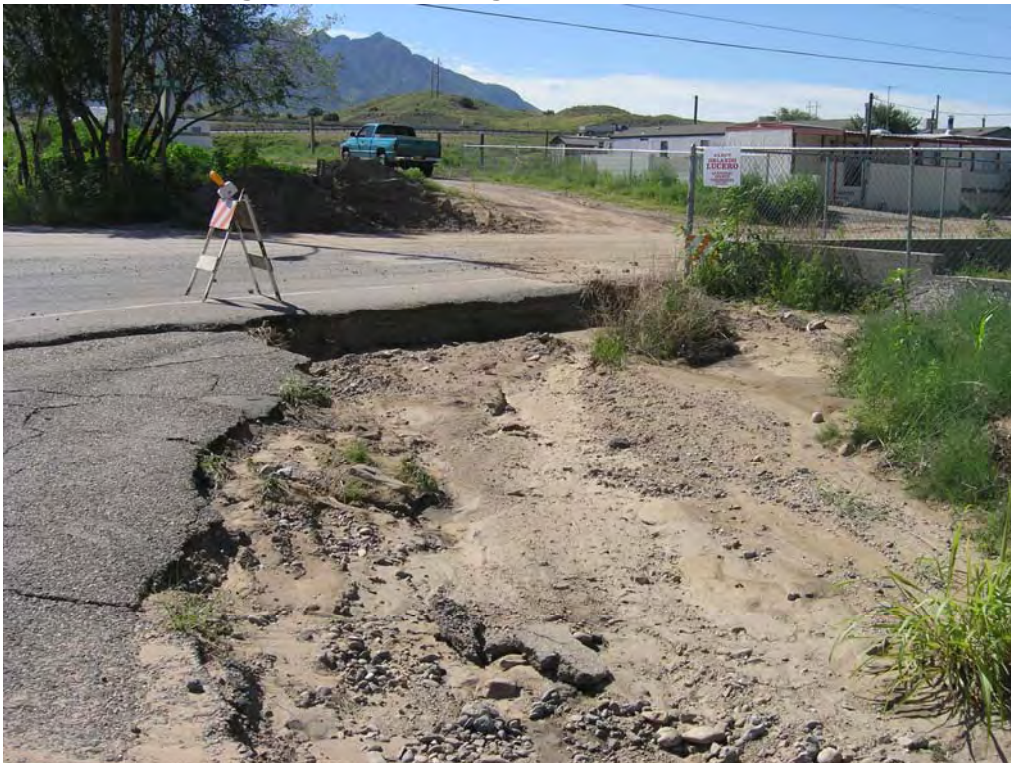
**Erosion due to high waters crossing South Hill Rd. at Avenida Bernalillo**

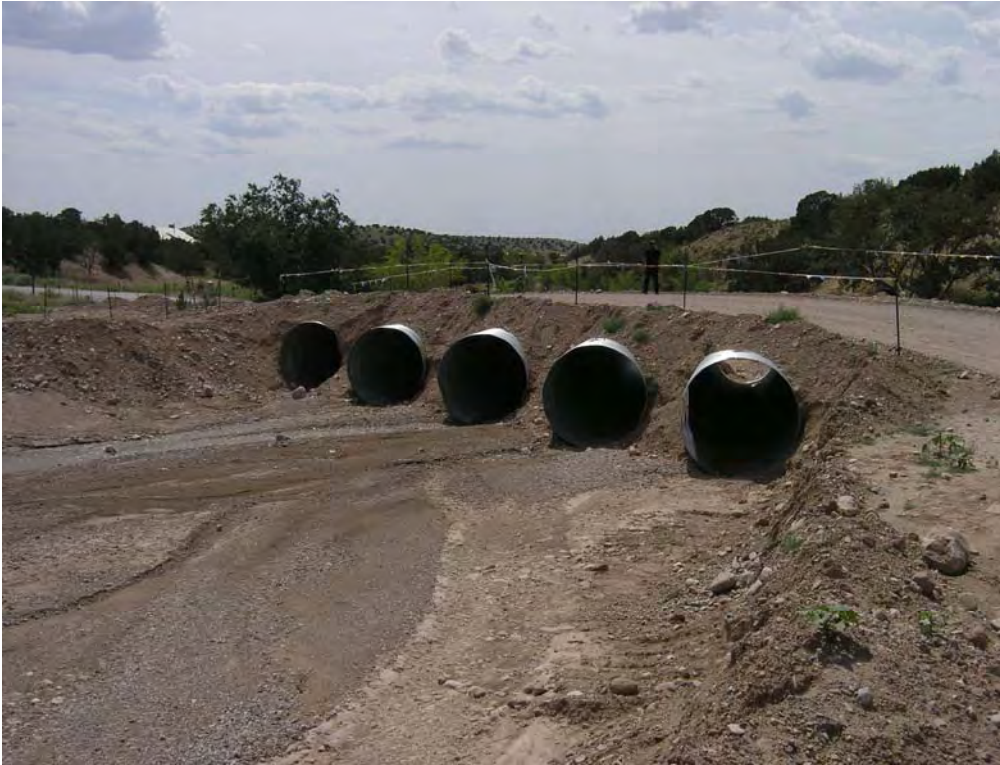
**Replacement culverts due to 2006 road washout on Camino de las Huertas**

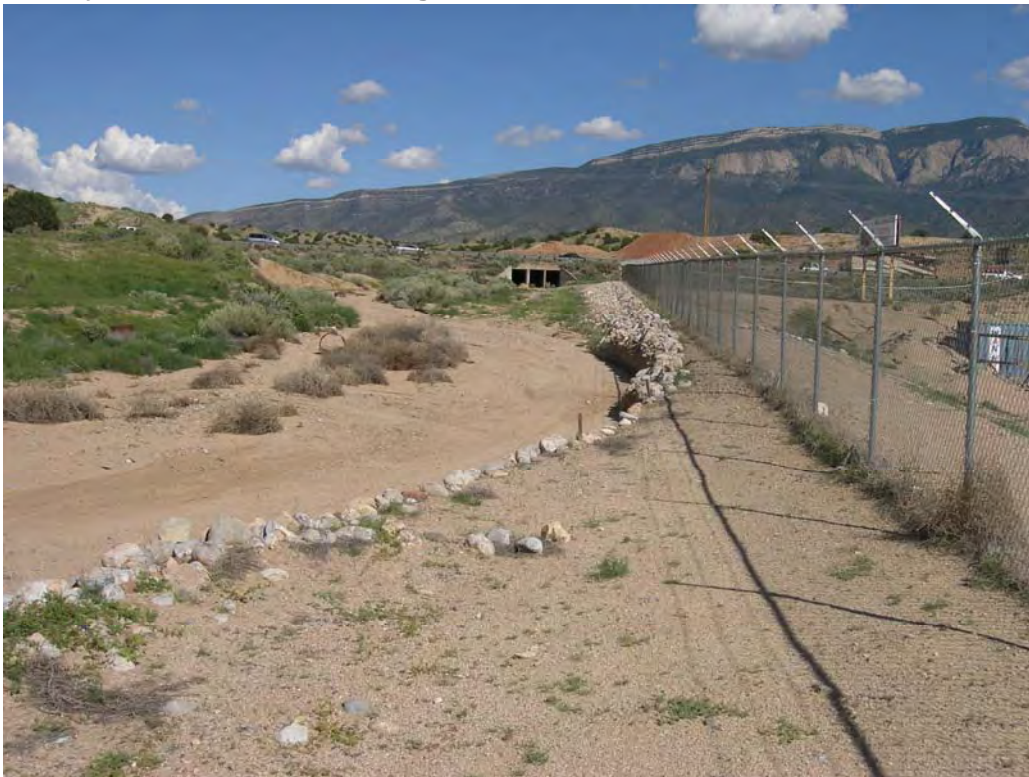
**Arroyo meander encroaching on commercial site**

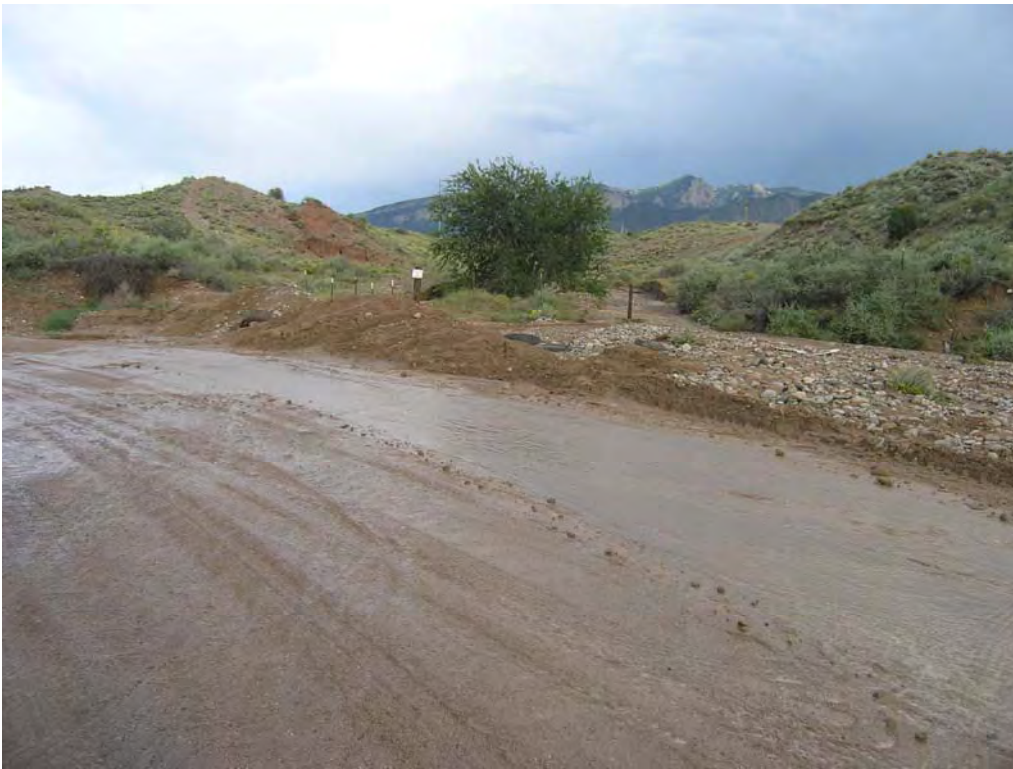
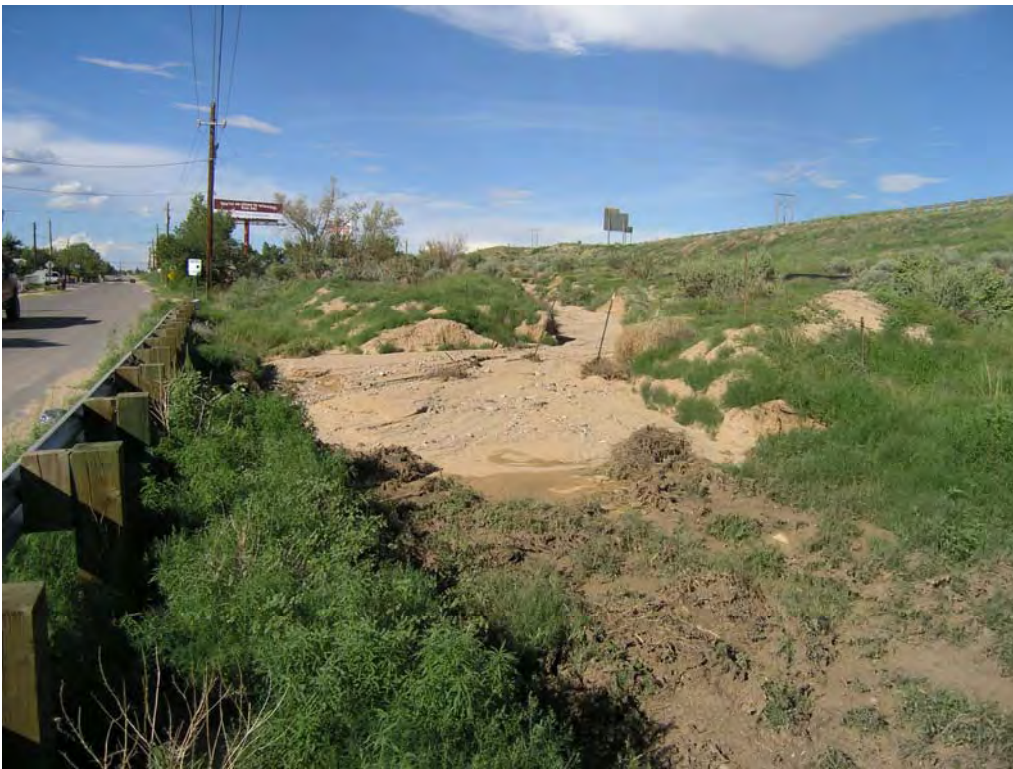
**Sediment-laden reaches that contributes to South Hill Rd.**

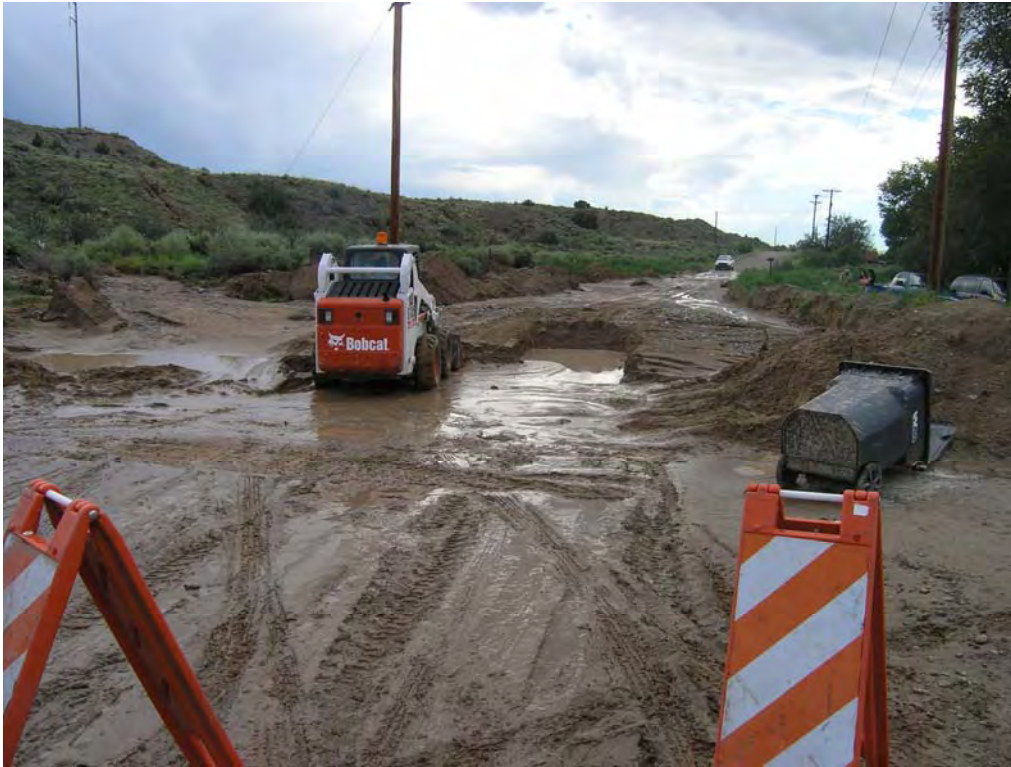
**Sediment deposition on South Hill Rd.**

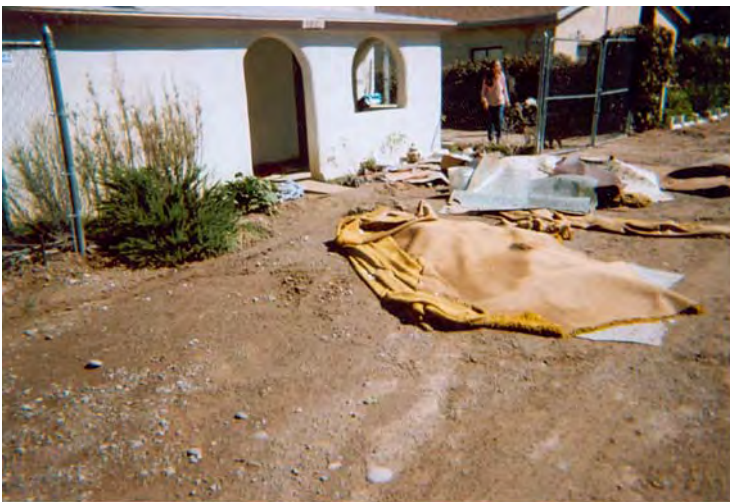
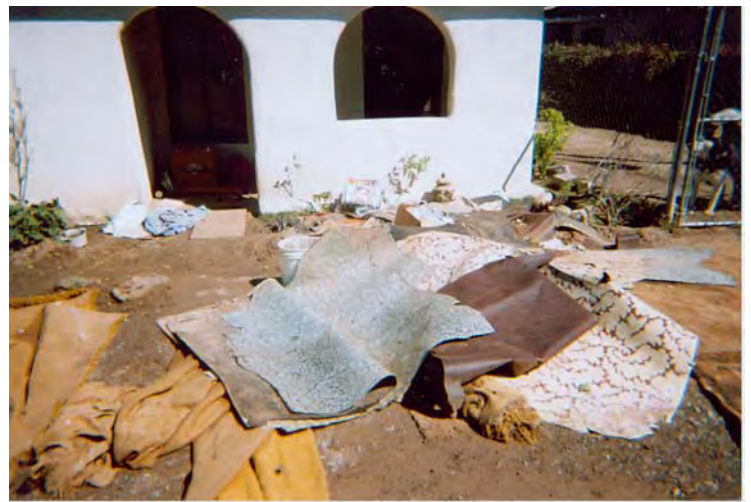
**Storm water damage to private residence along Avenida Bernalillo**

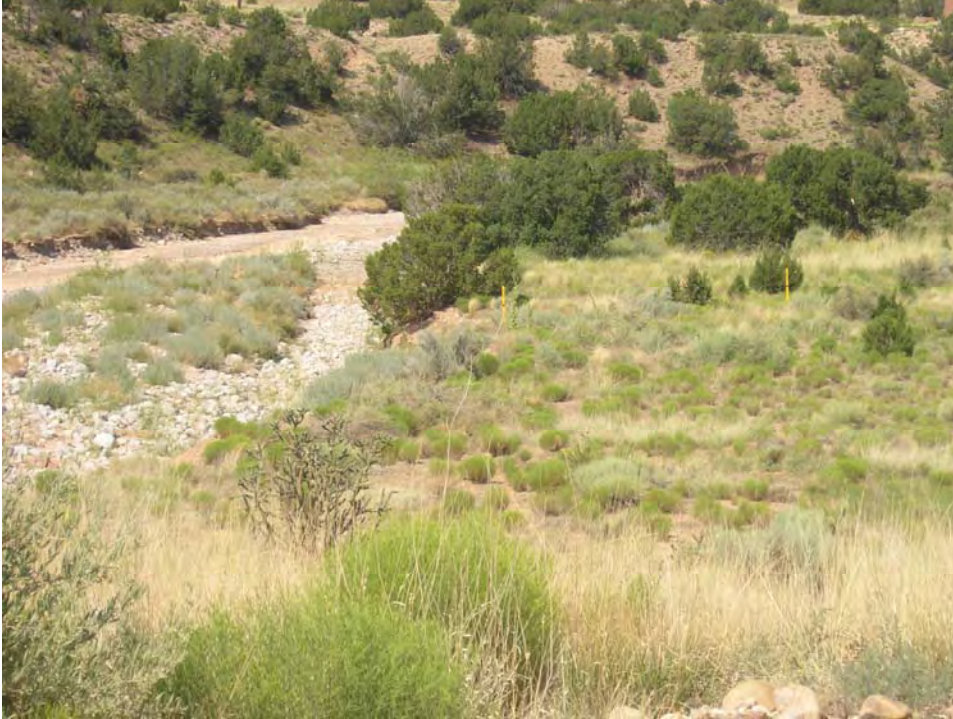
**Utility pipeline markers looking southwest from Windmill Trail just west of Indian Flats Rd**

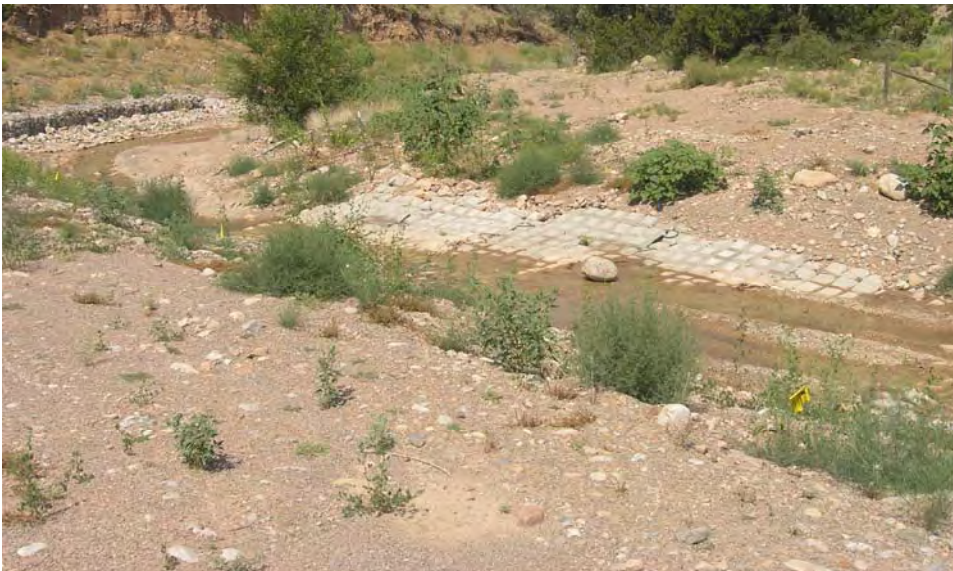
**Concrete erosion control blanket over utility pipelines just west of Camino de las Huertas between Cedar Creek Rd. and Windmill Trail**

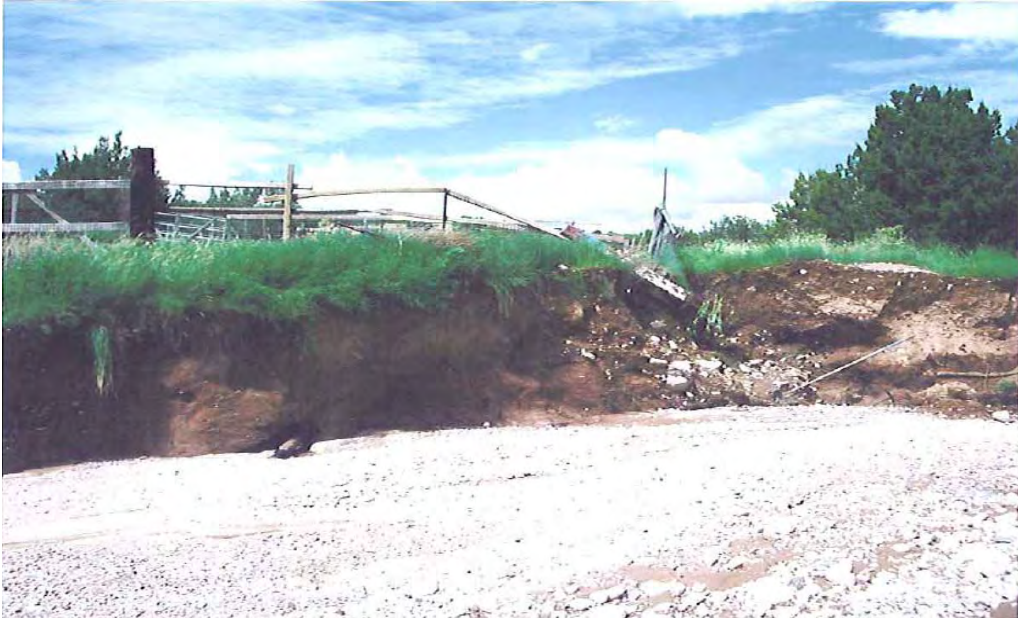
**Exposed pipelines on Las Huertas Creek**
