CORONADO SOIL & WATER CONSERVATION DISTRICT
FY17 WQ&C GRANT, Updated PO # 165002
4th Quarterly Report and Final Report
GULLY EROSION CURTAILMENT IN THE PLACITAS OPEN SPACE

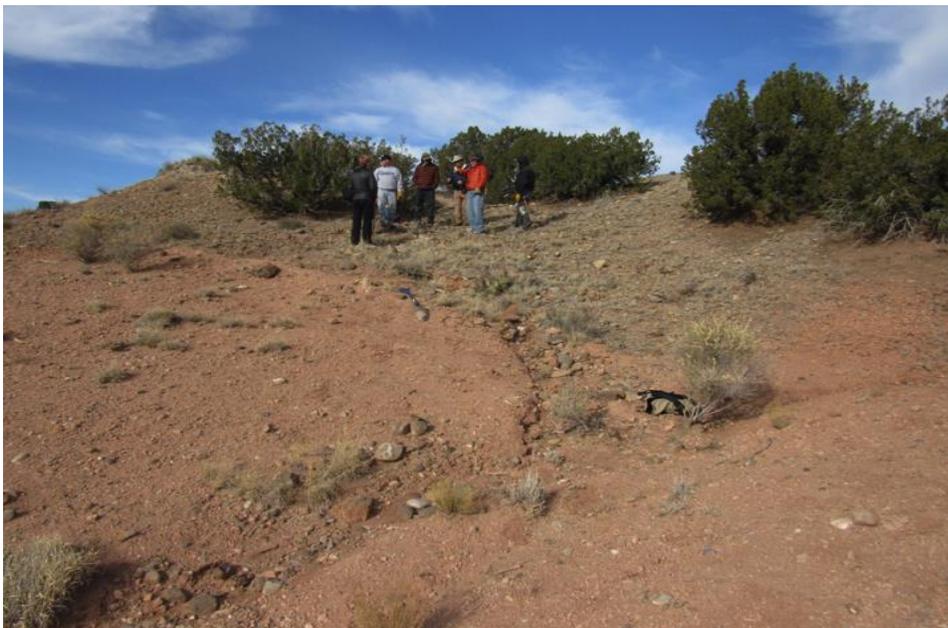
Project Objectives. Following the observations of the previous project's technical consultant Jim Brooks, this FY17 project was designed to address the erosion-prone drainage areas between the slopes treated in the earlier project. A simple technique appropriate for slowing water in the as yet small but obvious natural rill patterns was applied in between three slopes in the project area. The intent of the design was to apply water-slowing techniques in the drainages, linked with the water-slowing function of the swales already in place across the slopes. The goal is to inhibit the likelihood of further incising in the drainage areas leading to the creation of full-blown gullies over time, due to the typical intermittent but often extreme run-off events. Slowing and spreading the run-off will reduce the amount of sediment being carried to the larger drainages, and make available more water infiltration for the restoration of natural vegetation to protect these drainage areas from severe erosion.

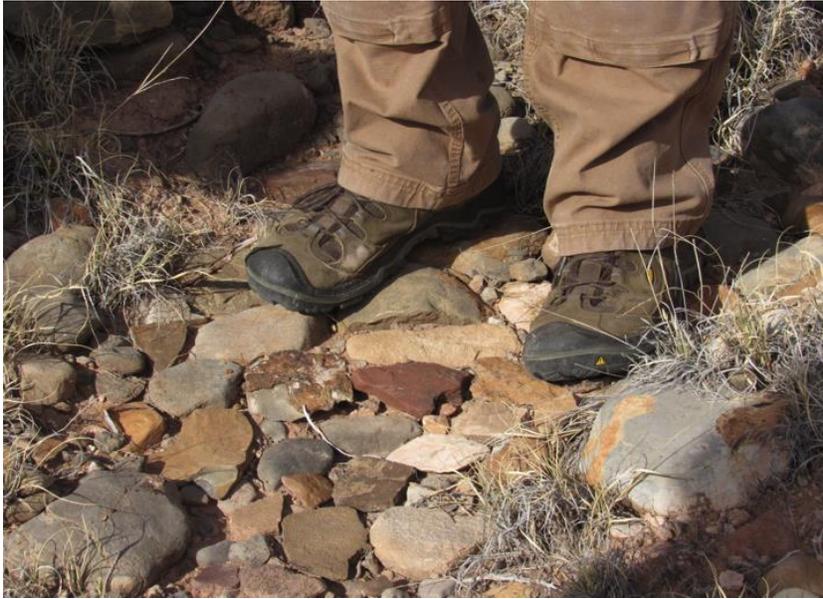
Treatment. The permaculture-type approach used for this task is referred to as one-rock plating. For this, rocks were laid in “plates”, about three feet long, one layer deep, and every five feet or more, depending on the contours of the rill area being treated. Rocks, relatively flat in nature, were gathered from nearby areas, fitted together by hand, and stabilized with hand pressure and gravel in the narrow cracks between the rocks. These plates were placed in the lowest areas and up the sides where past flow was evident.

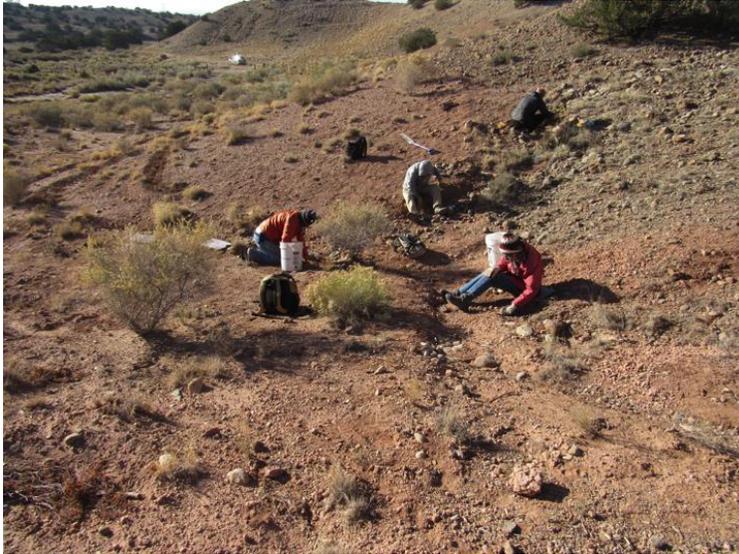
Design. The FY2017 project was carried out in the Placitas Open Space, from December through April, on a schedule of twice a month. Volunteers were recruited to do the rock plating. Counting the participating members of the Coronado SWCD, there typically were 5 or 6 people in the work sessions. The instruction for the rock plating was provided by Mr. Jim Brooks, contracted to participate with the volunteers in an initial training session on the work site, and again at the end of the project to look at the areas where the rock plating had been applied.

Along with tools used for the FY16 project, the tool most useful and purchased for this project is a soil knife, several of which were purchased. Volunteers were also supplied with kneeling pads, which the project staff crafted out of thick carpet squares that had been donated to the CSWCD. One of the volunteers also demonstrated to the project team the usefulness of a rubber mallet for getting the rocks well seated in the soil, which he brought for the sessions he worked.
