# Eastern Sandoval County Arroyo Flood Control Authority

INTERIM PRELIMINARY NEEDS ASSESSMENT

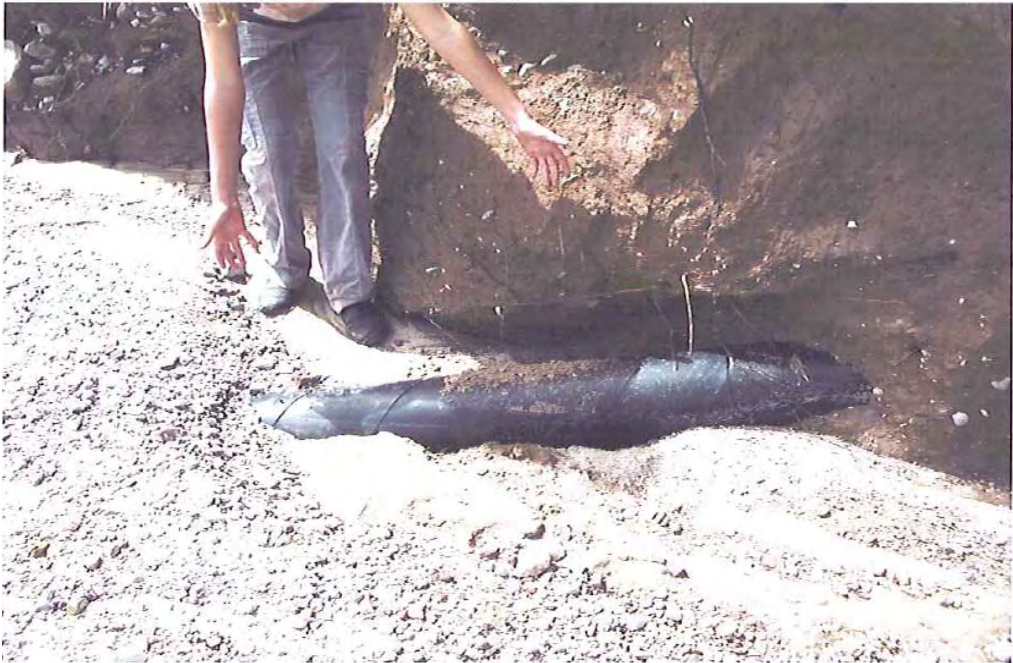
**Exposed pipelines on Las Huertas Creek**

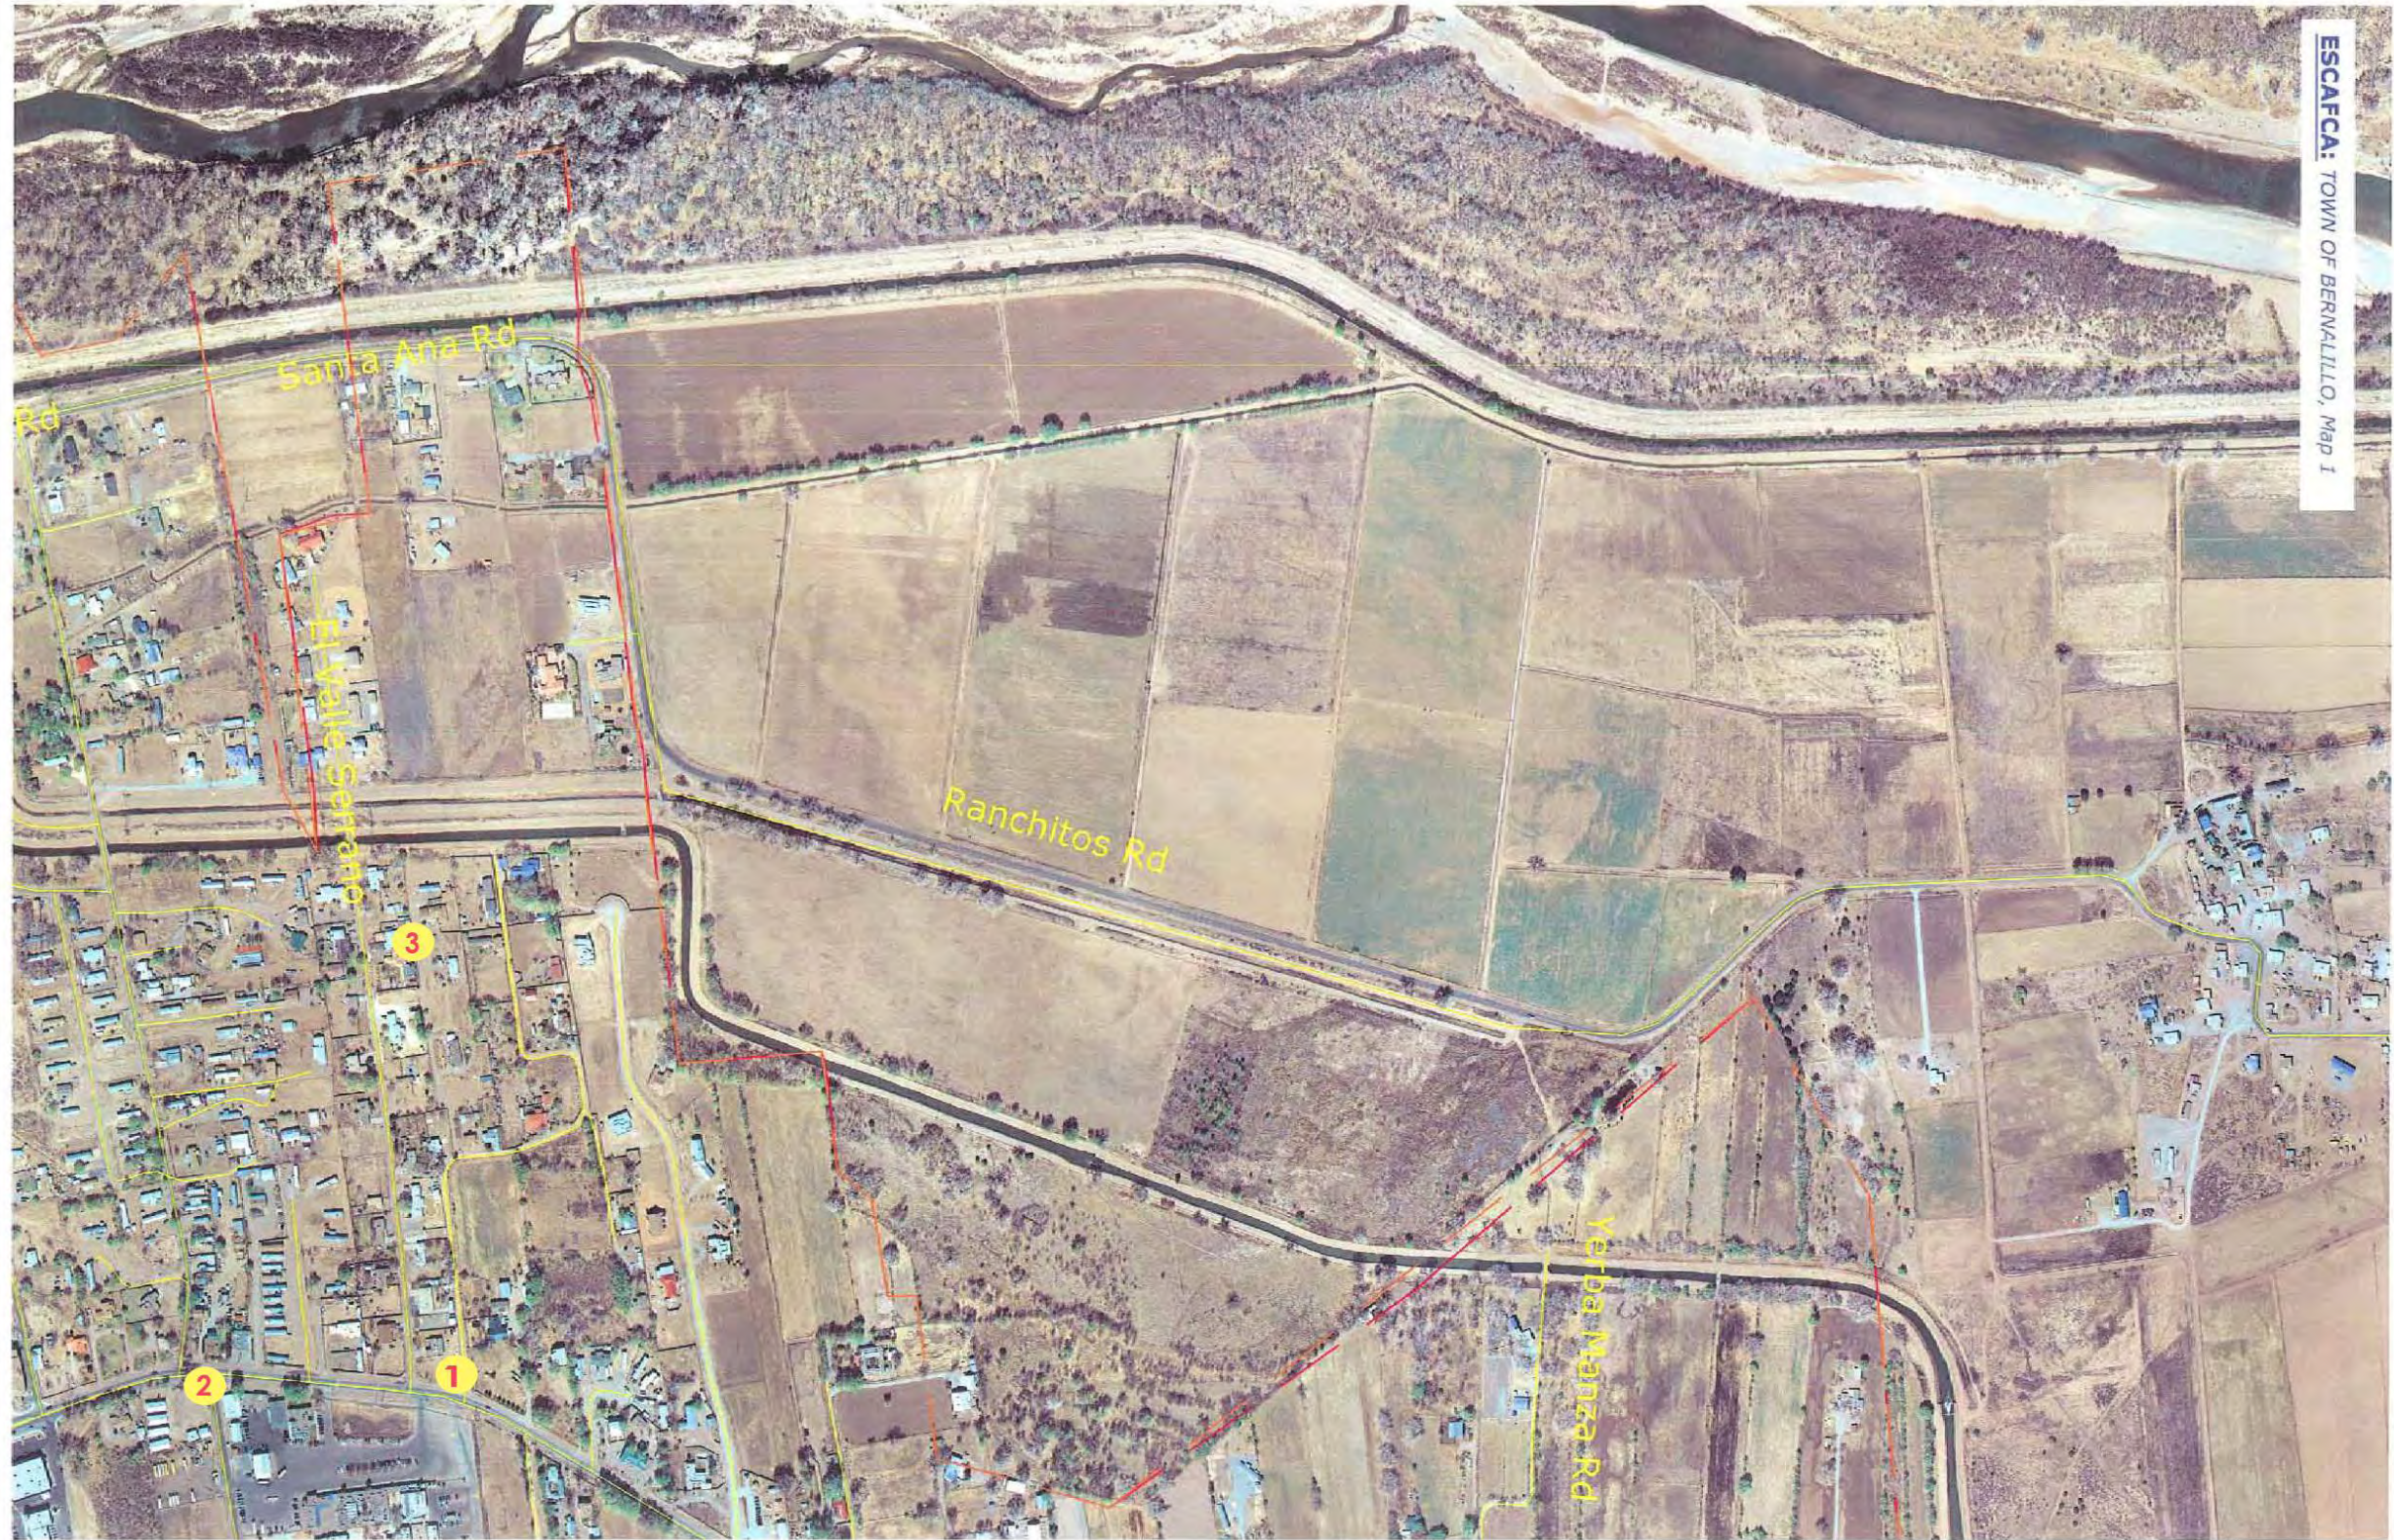
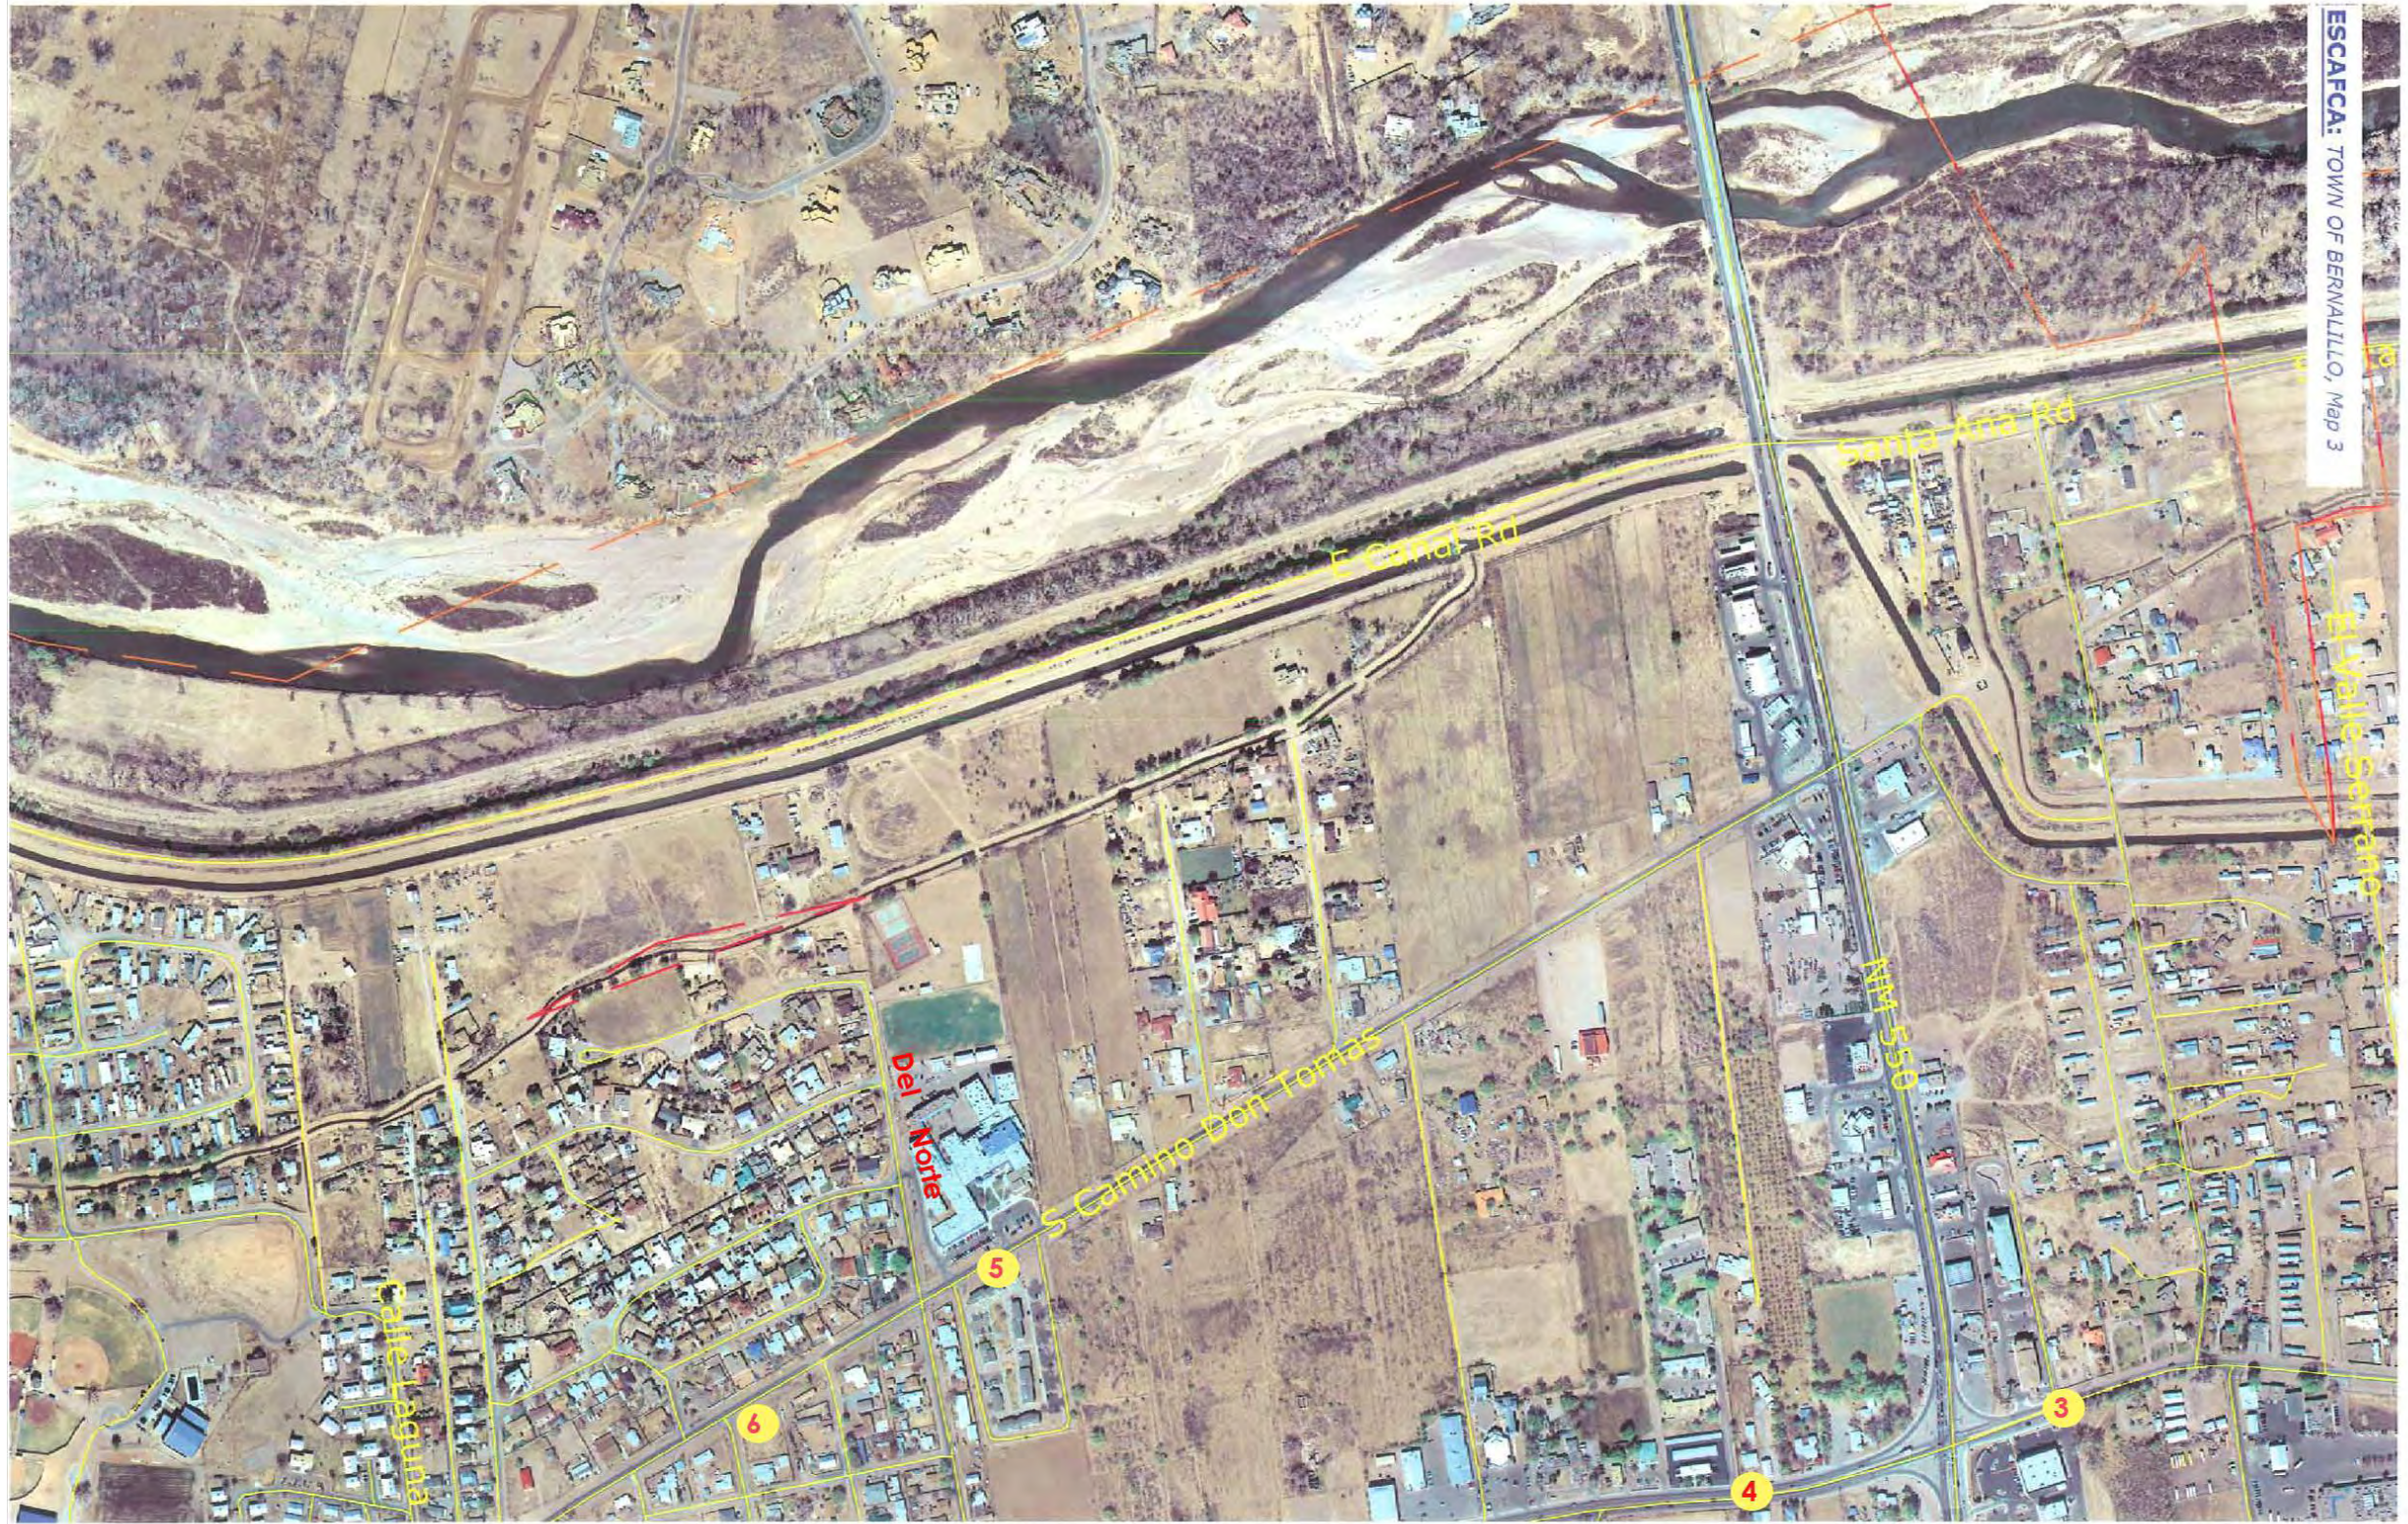
Comment #5–street adjacent to school floods, Del Norte houses don't flood but yards do.

Comment #6–floods on east side of road all the way to 550. General street flow issues.

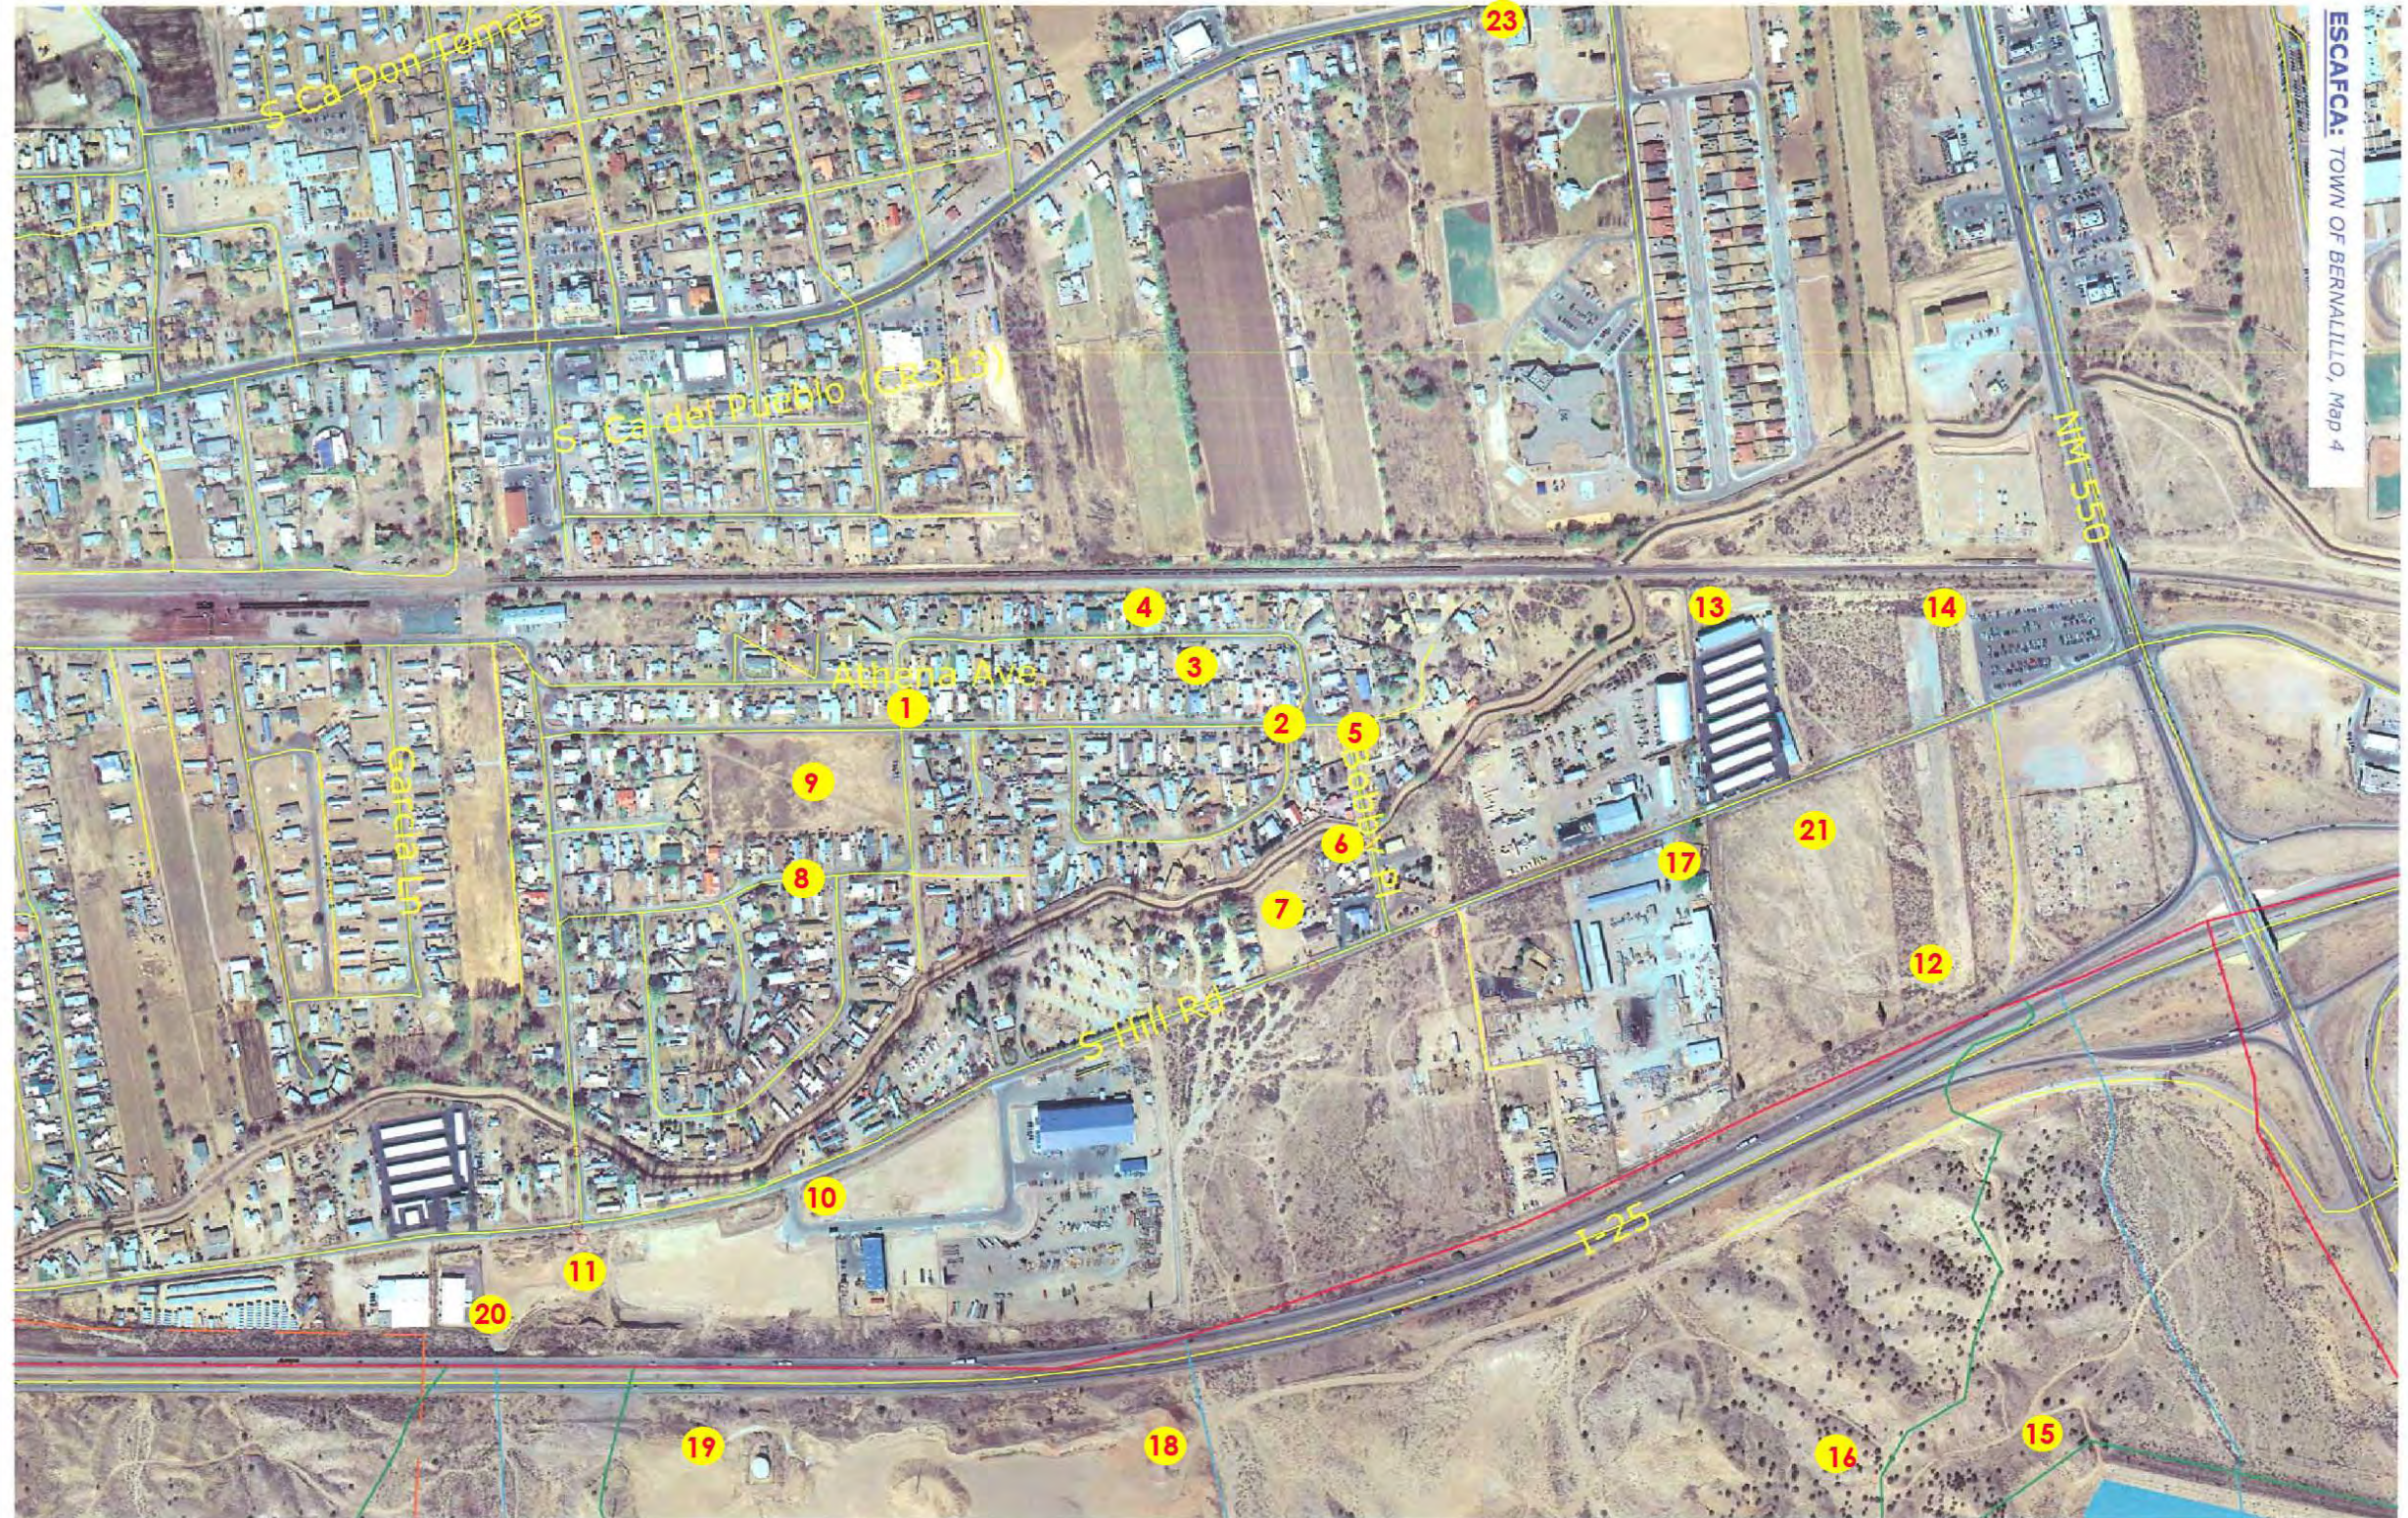
Comment #18- Boulders blocking natural arroyo east of I-25; loose fill to south; sand and gravel plant covered culverts east of I-25.

Comment #23-street floods almost every [rainfall], there is a pump station on the church property. Street is a low point.

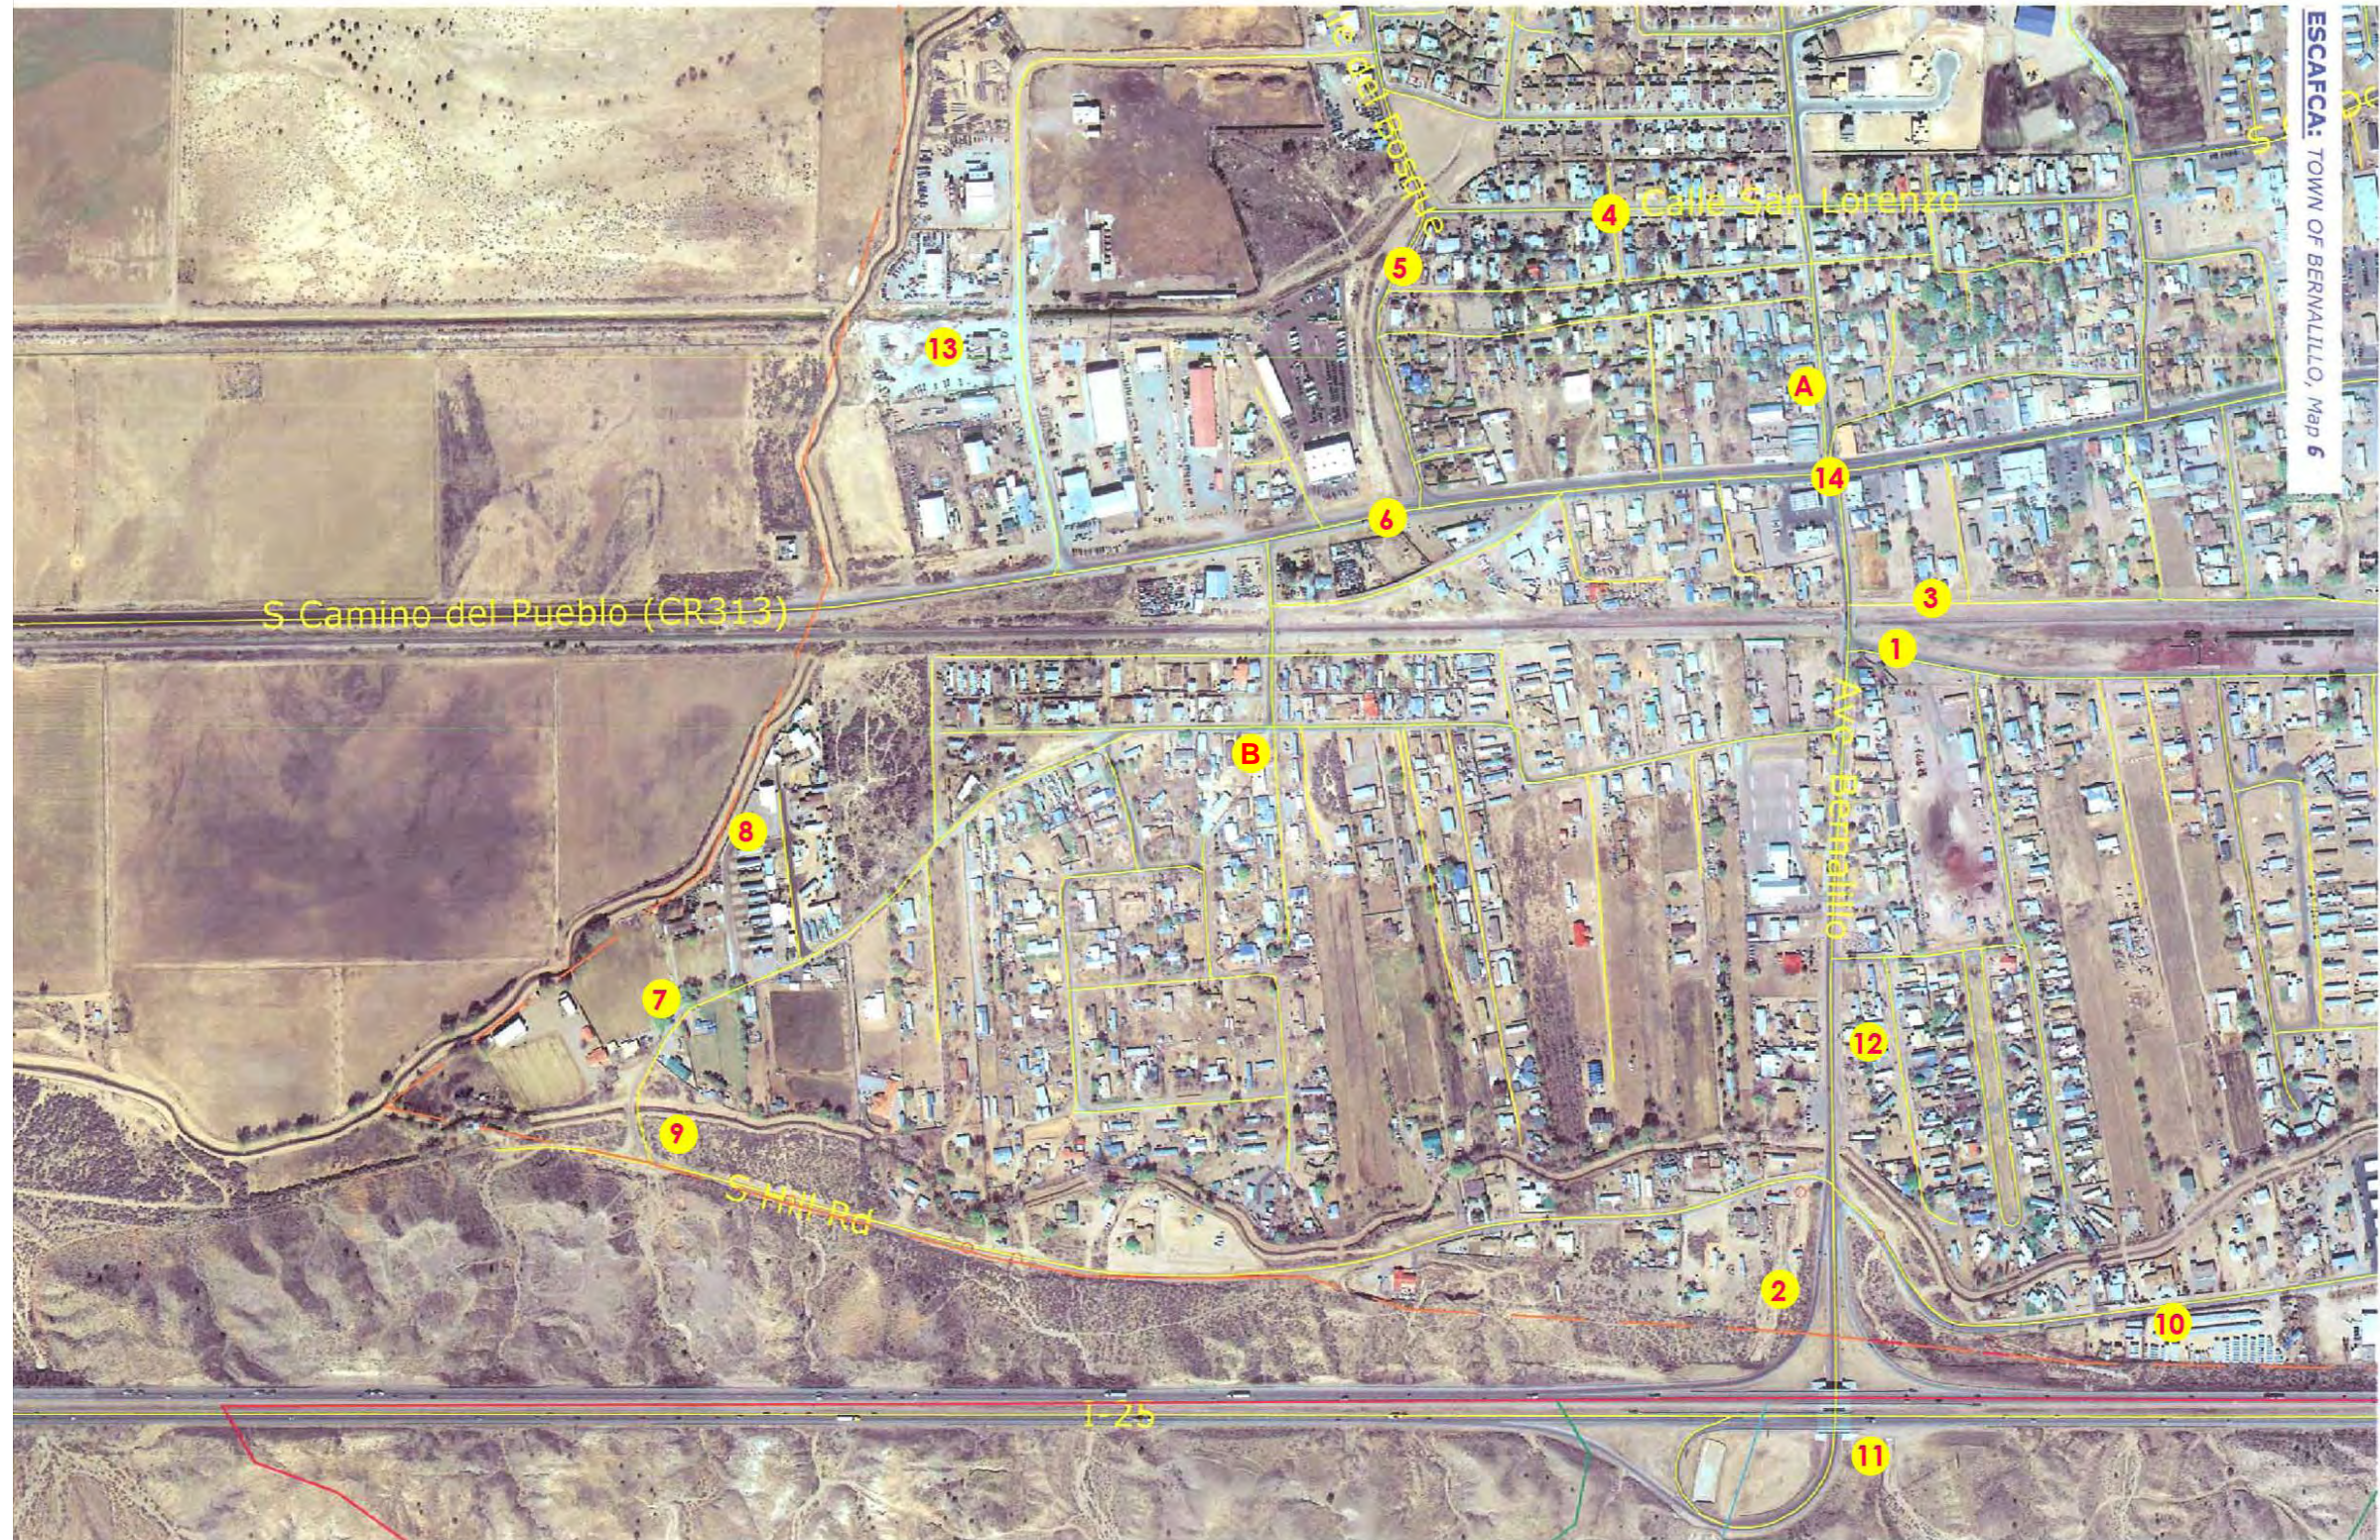
Comment #14 – (xxxx's former business with lease to Giant Gas Station). Bernalillo Avenue corner at Hwy 313. Floods even with a little bit of rain.

Comment #15 –undersized culvert; development upstream of dam 27 acres of commercial, 20 feet [of] base of dam. Biggest problem is other side of highway.; 2 flood[s] resulting in culverts failing.

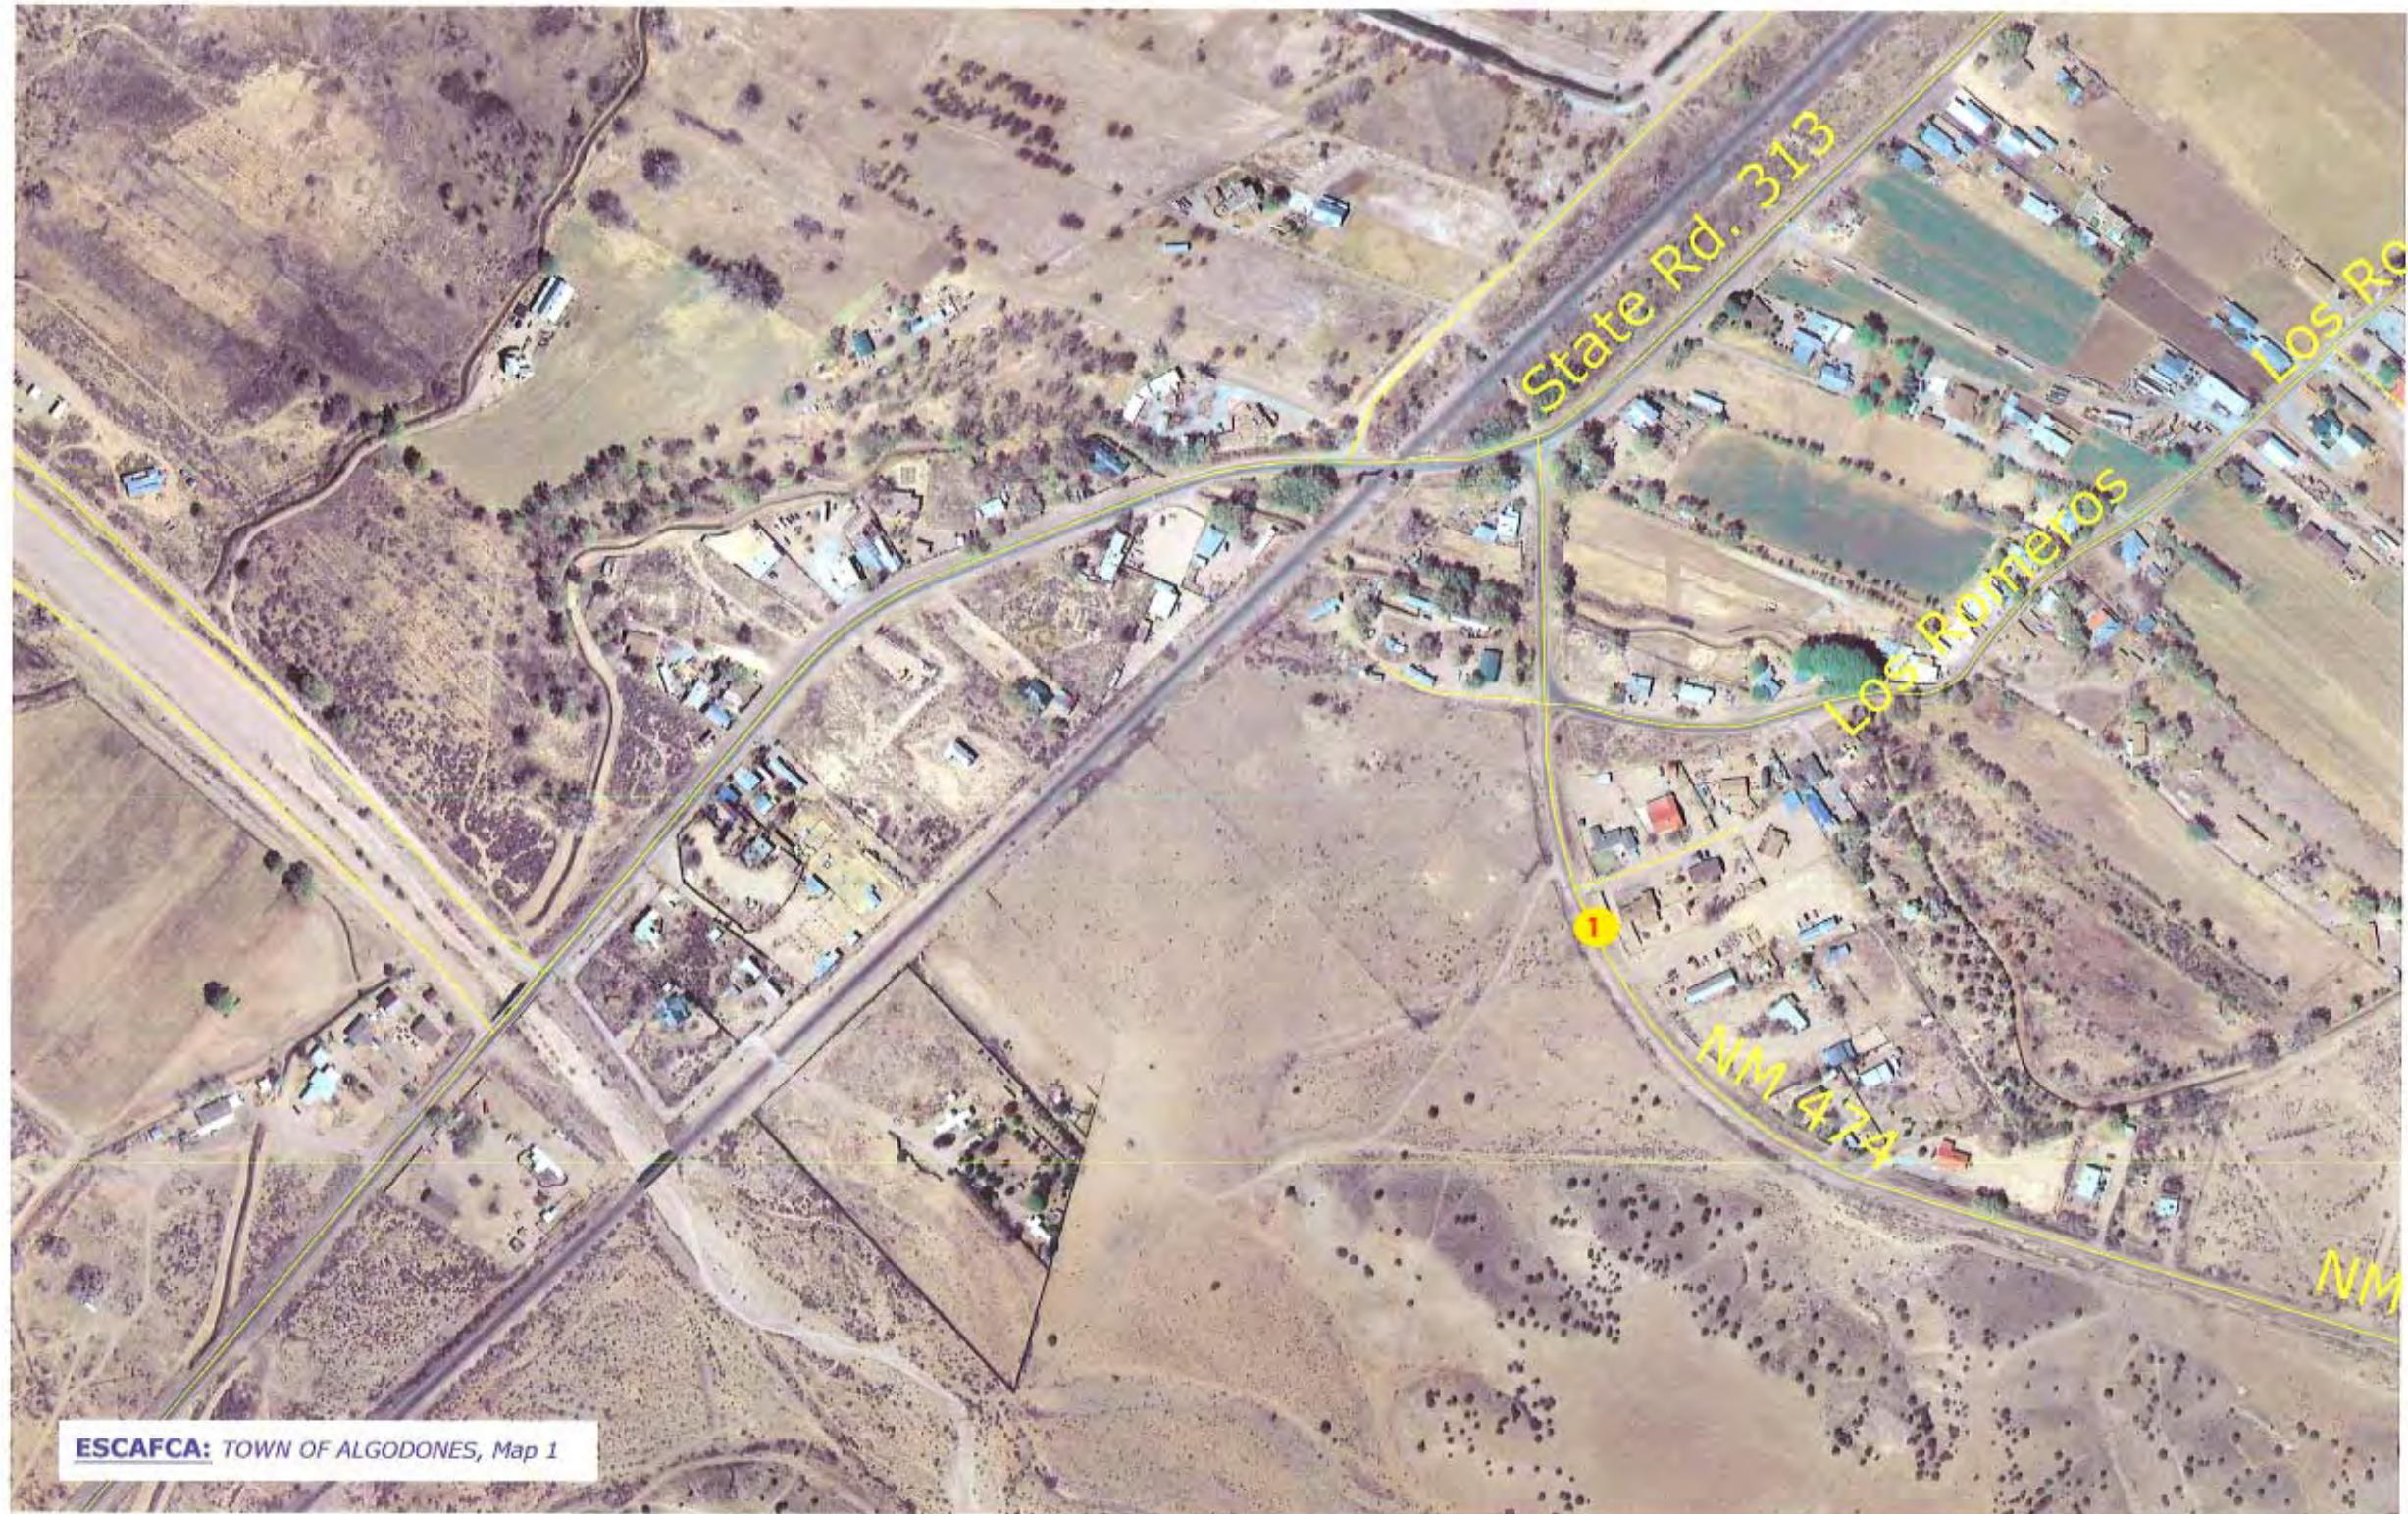
Comment #1– broken berms from runoff; MRGCD dikes fail and breach flooding channels that run westward into fields.

Comment #2–There are 4 inch to 24 inch culverts to handle 3 large box culverts [that move water from under I-25 to the west]. Ditch over flows because eastern drainage fills ditch and forces the water to run north; it breaks the ditch and floods areas to the east of the ditch.

Comment #3–area where basement flooded.
