# Eastern Sandoval County Arroyo Flood Control Authority

INTERIM PRELIMINARY NEEDS ASSESSMENT

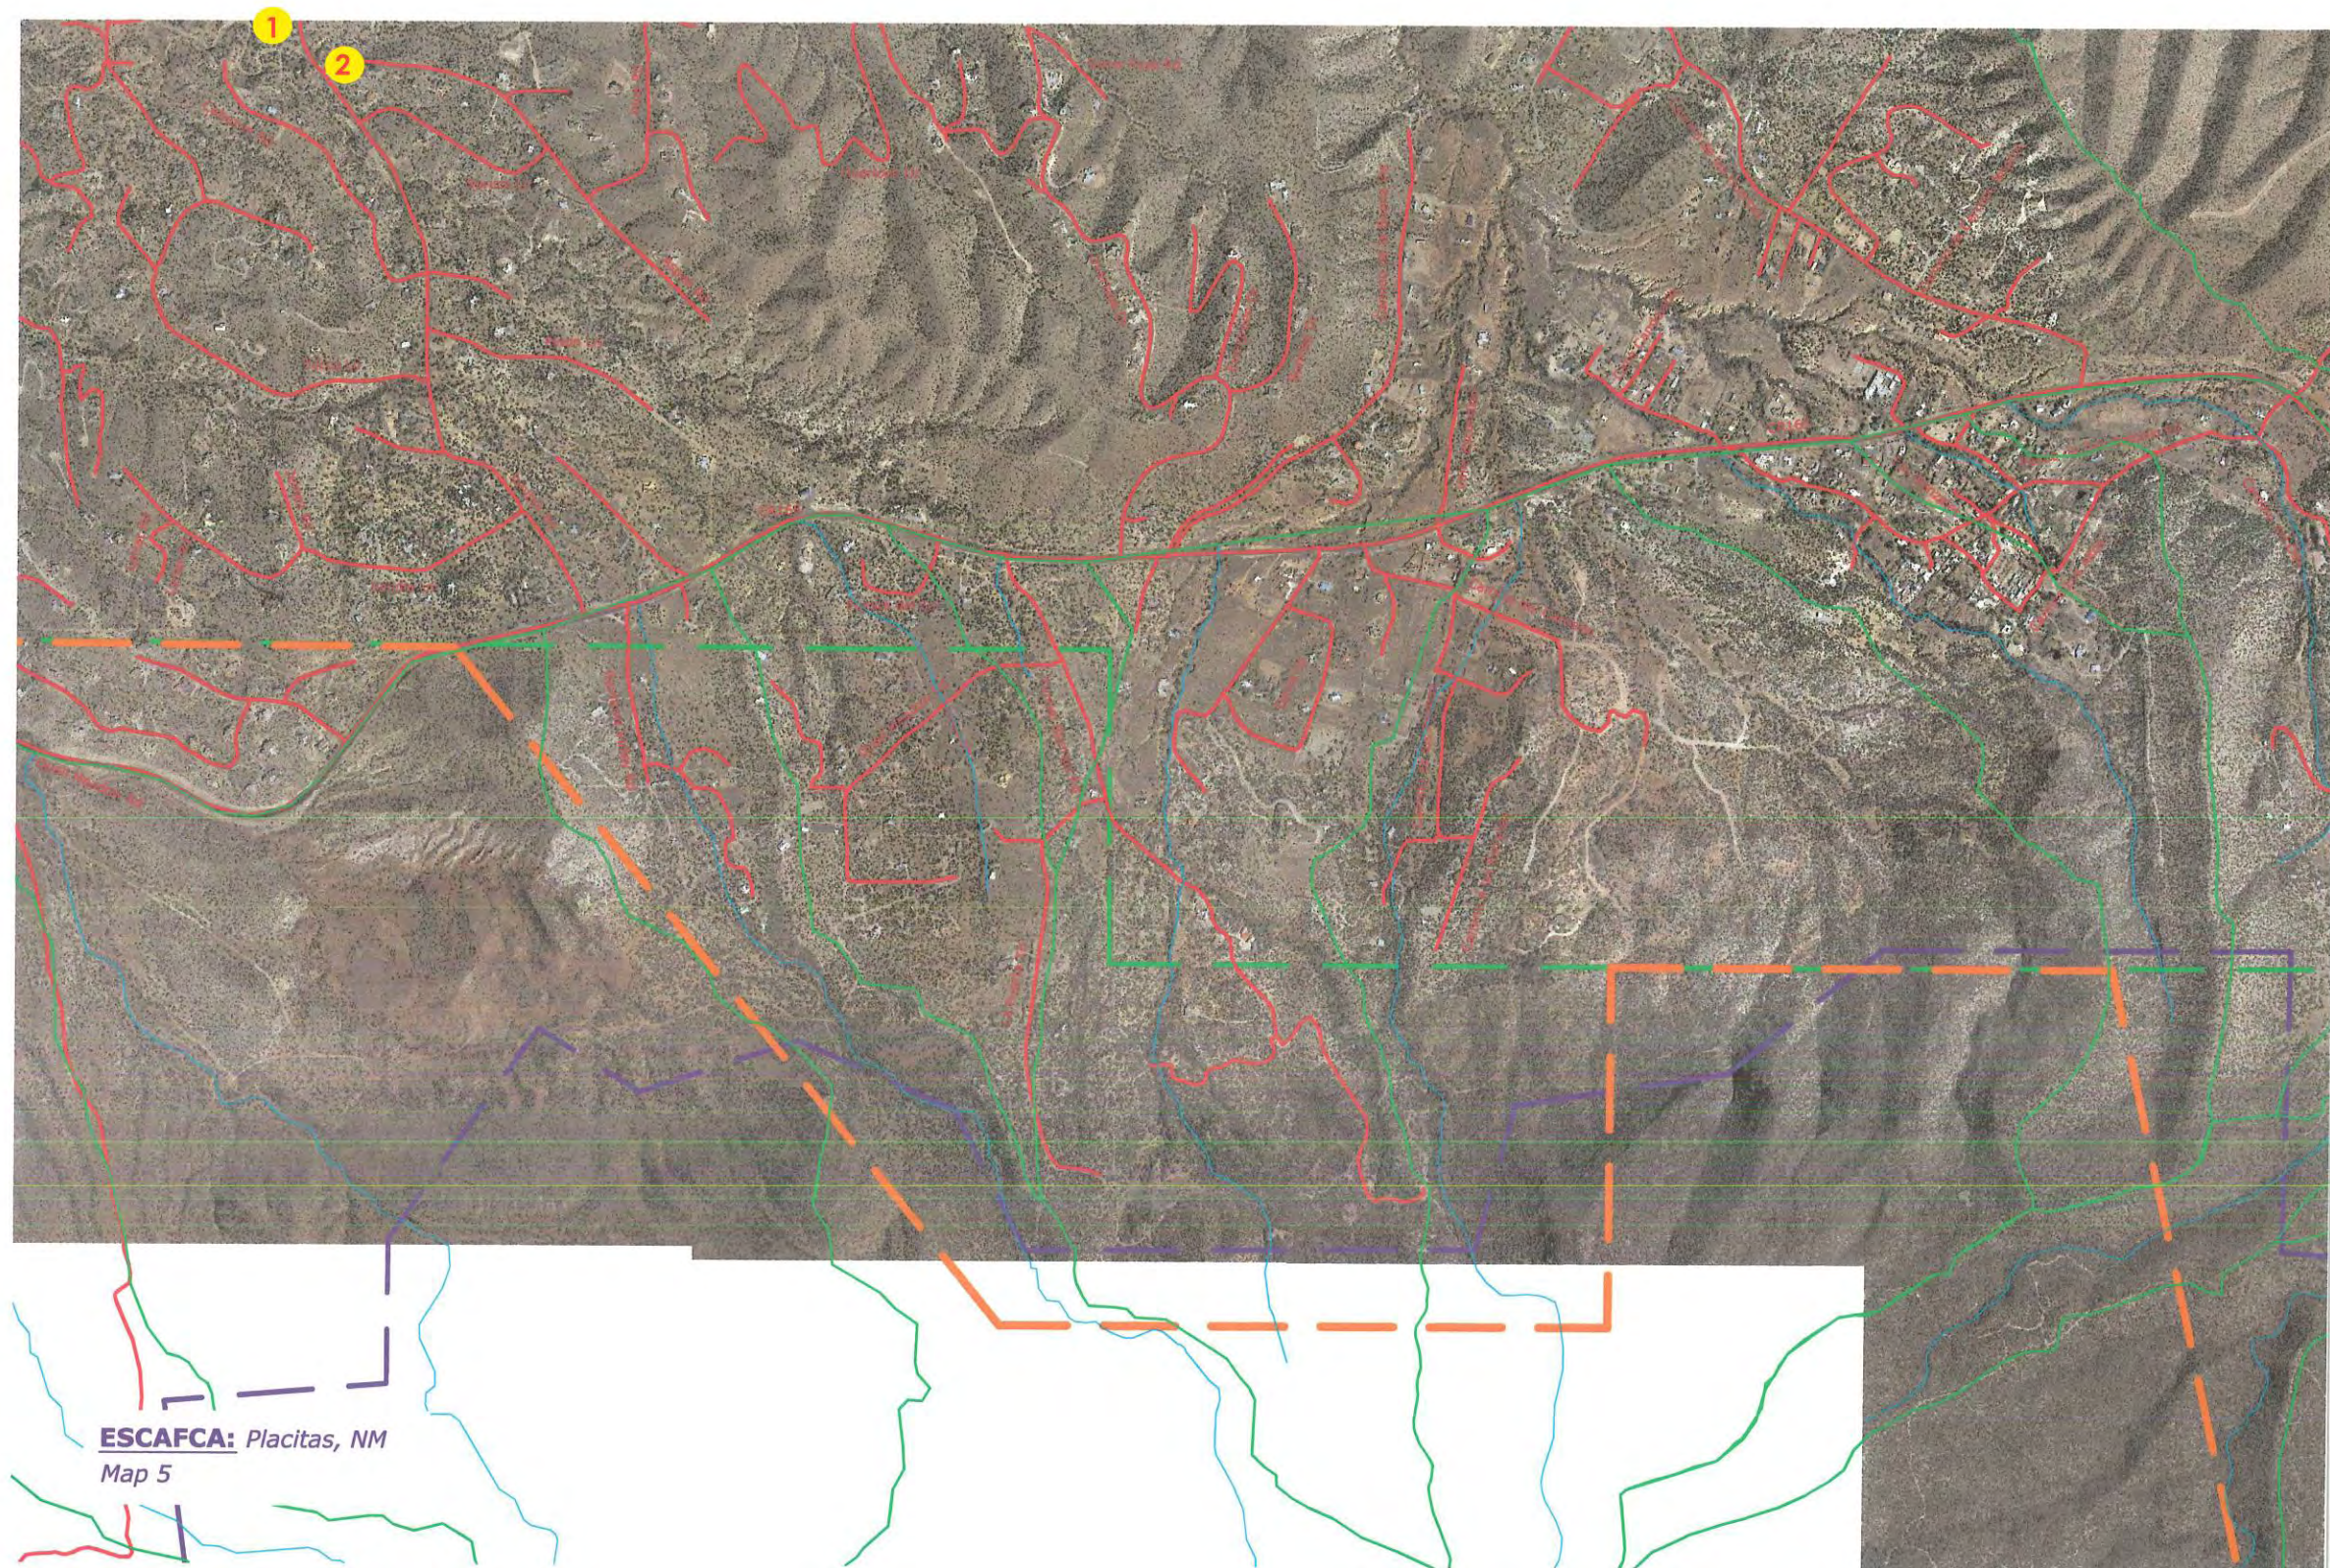
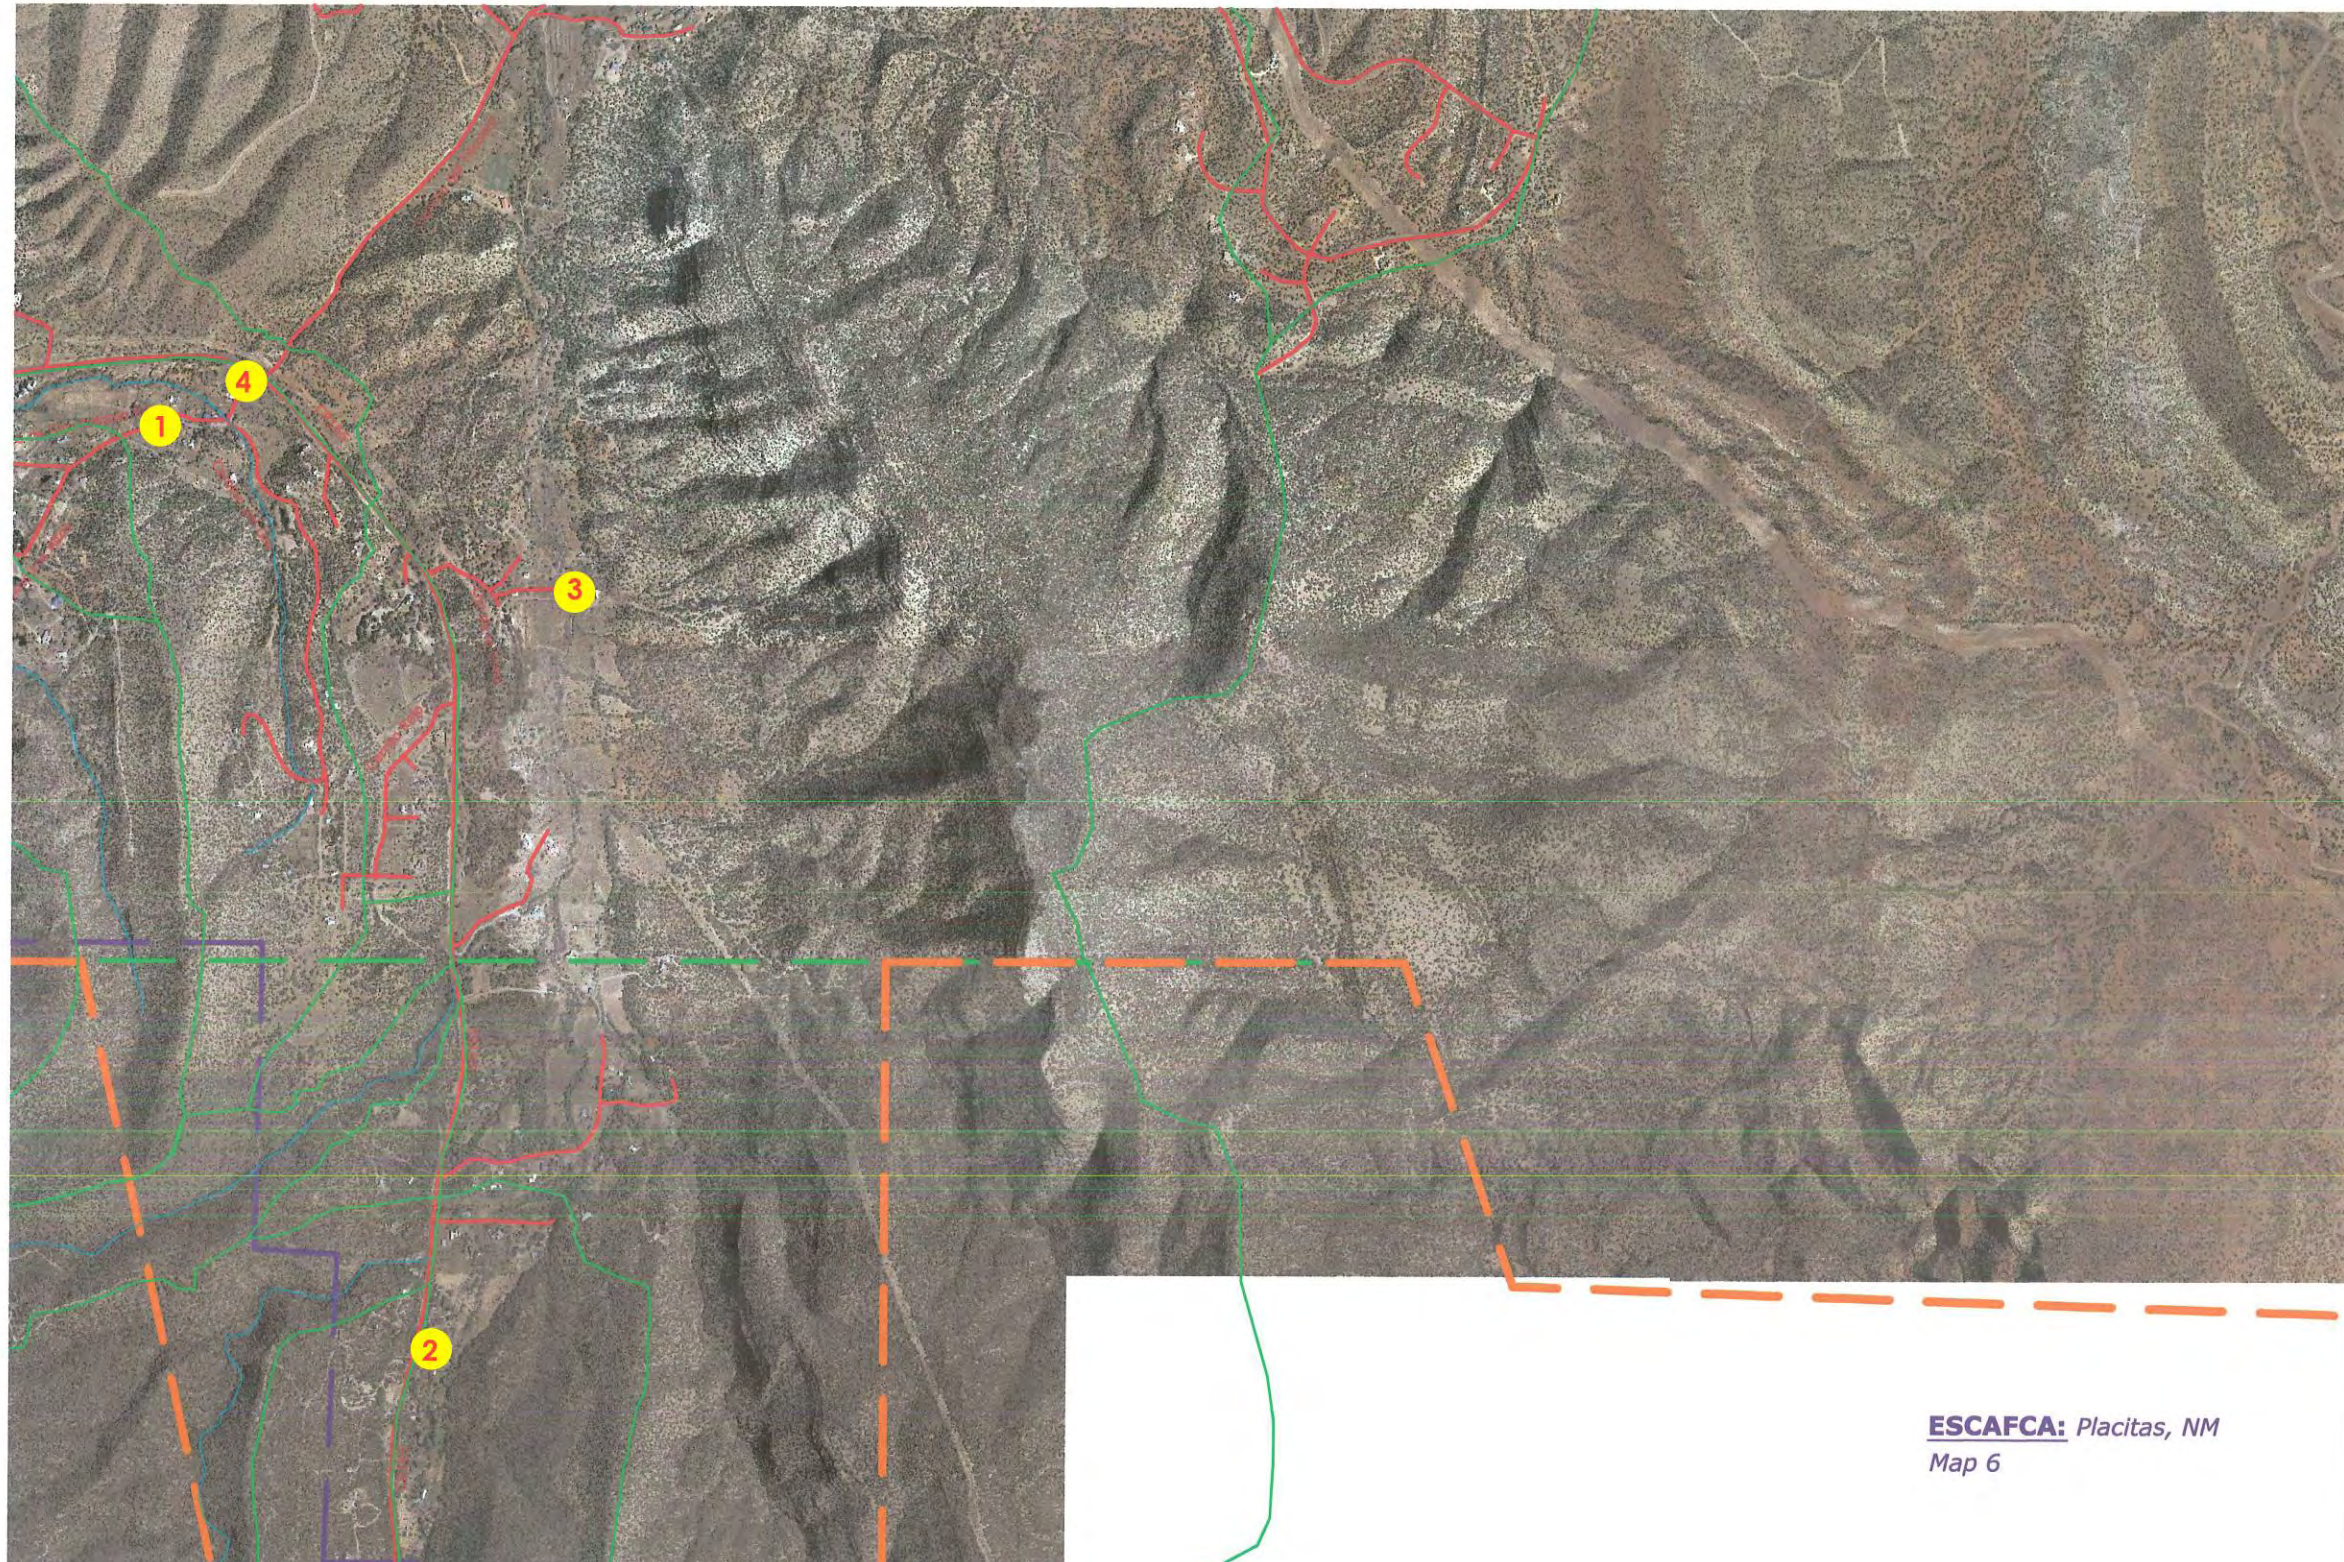
Comment #9 – (Interstate 25, west side, north of Avenue Bernalillo) Arroyo flow under I-25 then south. Blows out North Hill road and ditch.

Comment #10 – (arroyo drainage north of I-25 and Avenue Bernalillo interchange on east side of I-25) [precipitation] fills MRGC ditch
