Las Huertas Canyon
Watershed Restoration Action Strategy
(WRAS)

Version 2.0

September 30, 2005

Prepared by the Las Huertas Watershed Project, Placitas, New Mexico

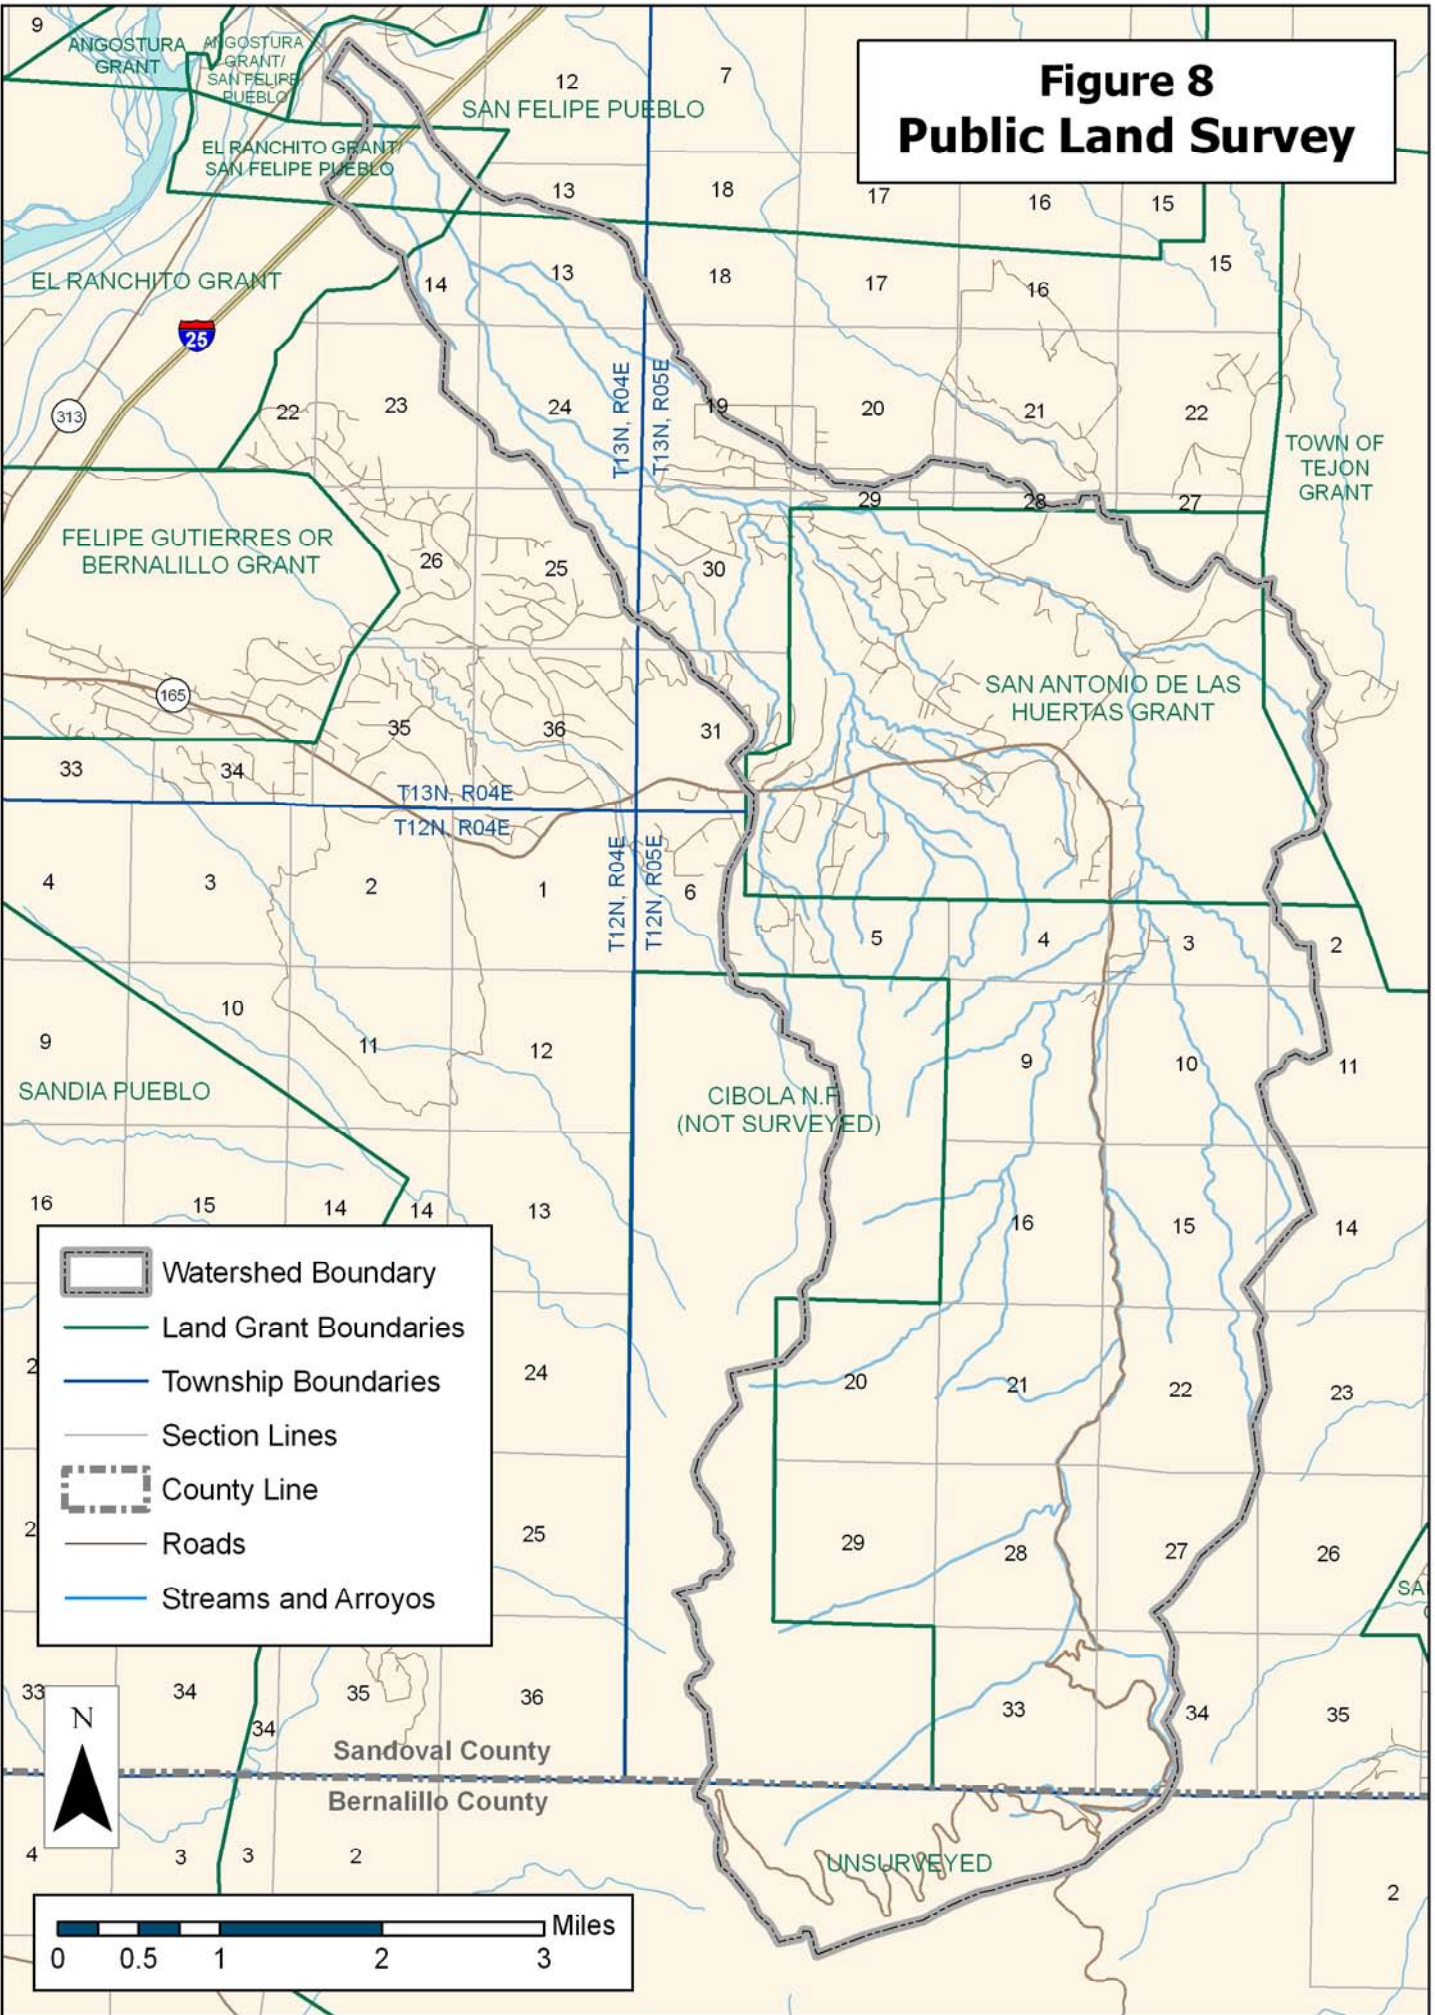
Figure 8 Public Land Survey

Map by Kristin Willeke for Las Placitas Association, June 22, 2005. Map projection and datum: UTM Z13N, NAD83. Primary data source: RG15, BLM 2003 statewide dataset. See metadata for details.

Watershed Boundary
	Land Grant Boundaries
	Township Boundaries
	Section Lines
	County Line
	Roads
	Streams and Arroyos

Figure 8 provides Township, Range and Section reference information, and illustrates historic land grant tracts in the area.

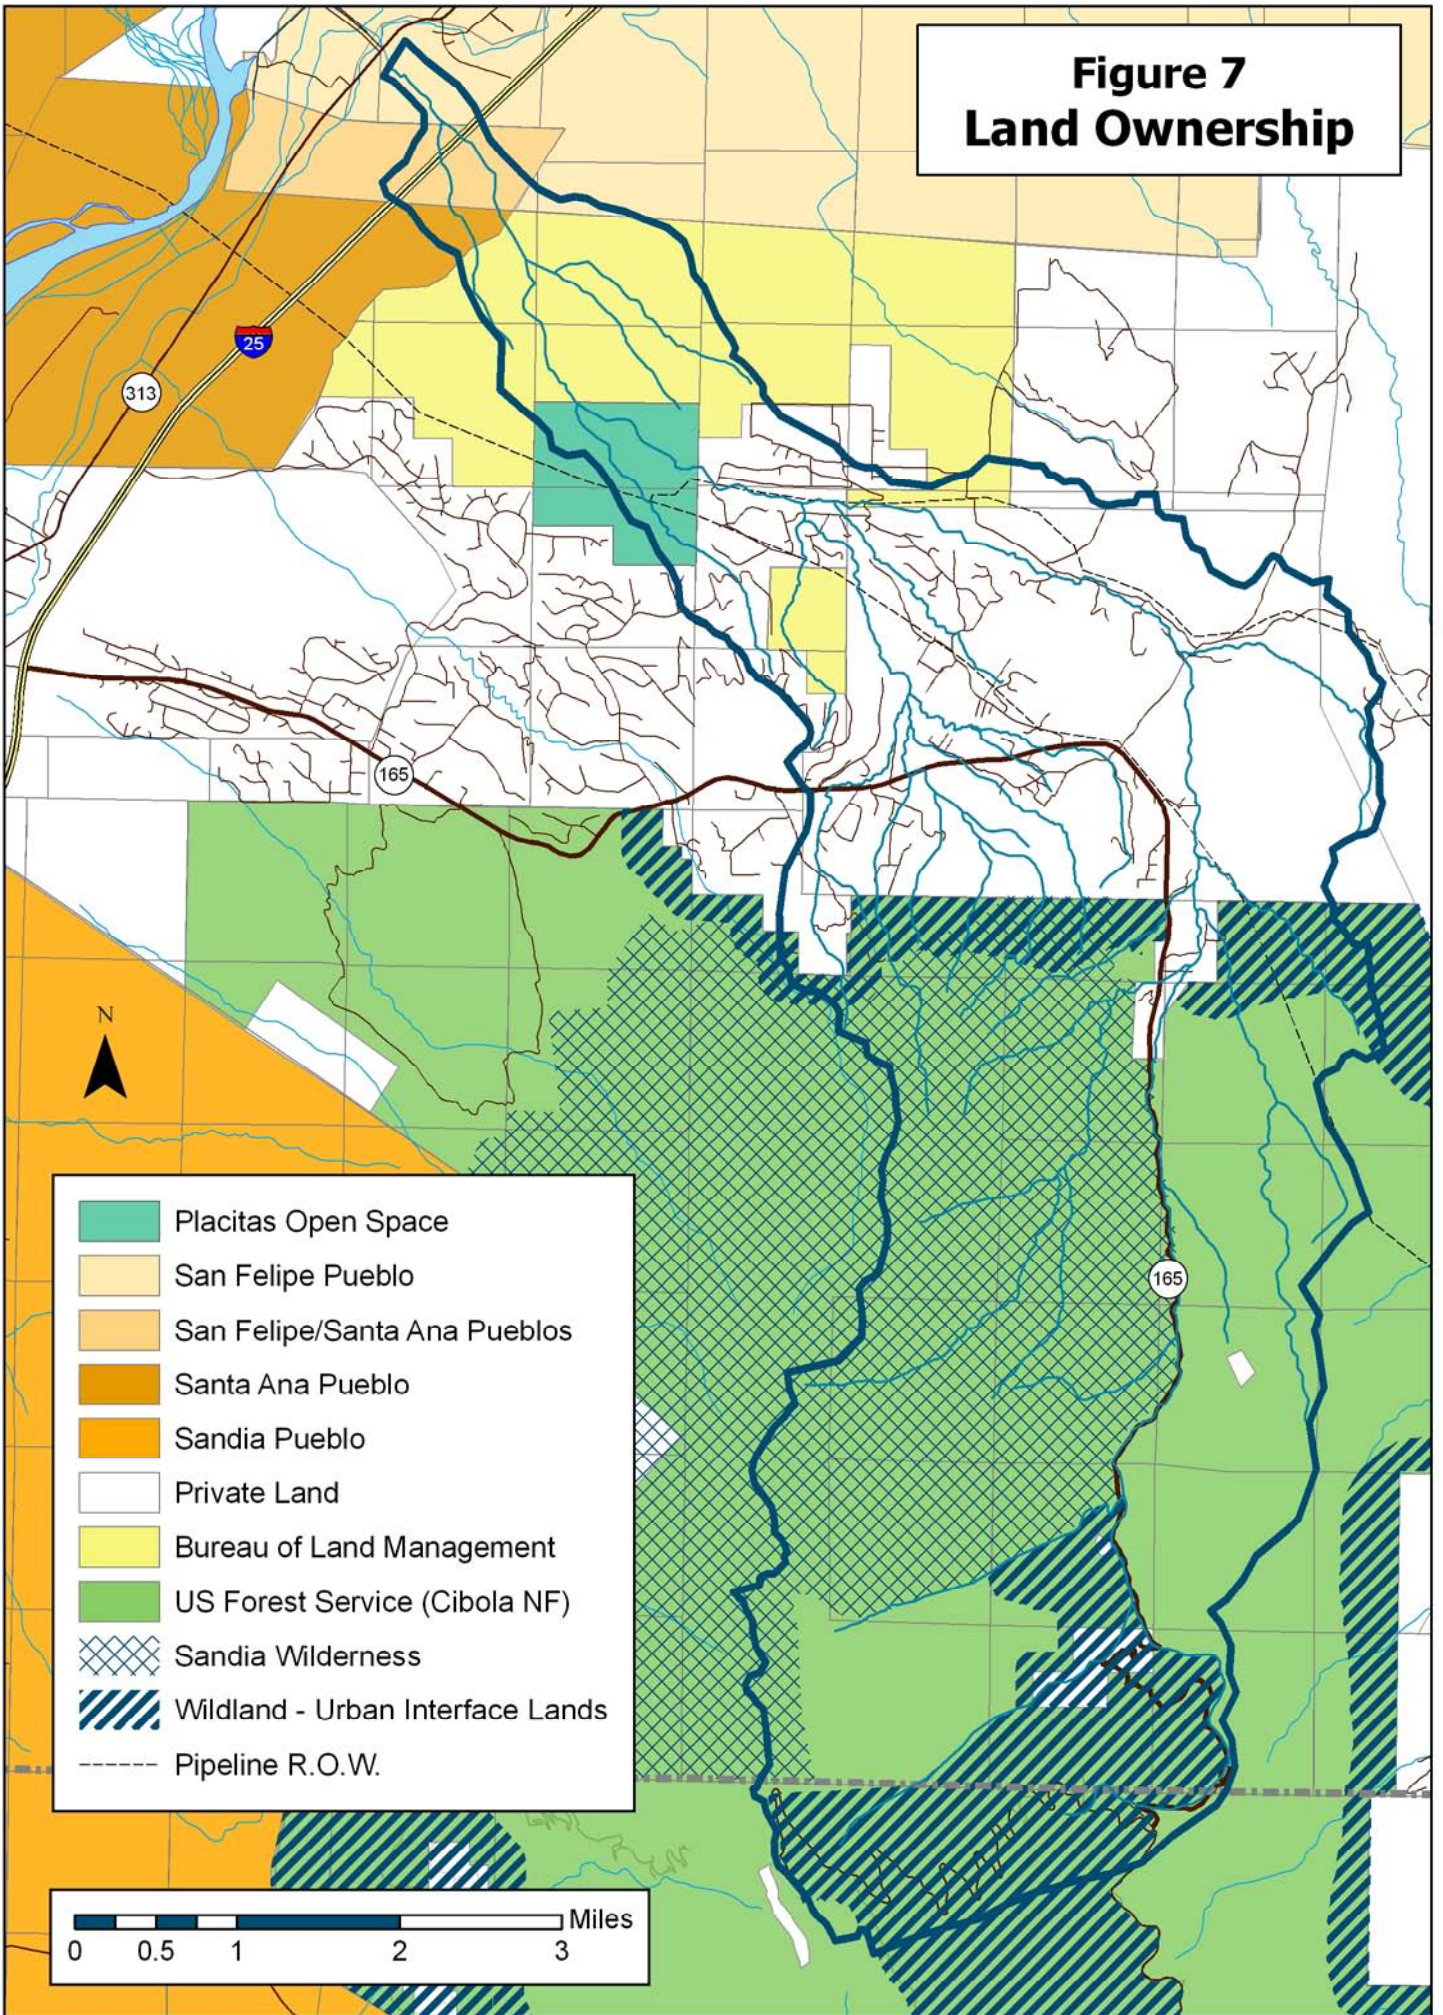
**Figure 7
Land Ownership**

Map by Kristin Willeffe for Las Placitas Association, June 22, 2005. Map projection and datum: UTM Z13N, NAD83. Data sources: RGIS (BLM data), Sandoval County (Indian lands), Albu Open Space program, USFS WUI program.

Land Ownership/Land Use. A variety of entities own land within the Las Huertas Creek Watershed (Figure 7). Land uses associated with land ownership vary. The United States Forest Service (USFS), Bureau of Land Management (BLM), City of Albuquerque, Sandia and Santa Ana Pueblos manage areas in the watershed (Nelson, 2005). USFS manages the largest amount of acres within the watershed, which begin at the headwaters. Private property owners hold approximately 30% of land in the watershed. Placitas Open Space (POS) is part of the City of Albuquerque's Open Space holdings, and is located approximately three miles northwest of the village of Placitas.

The T'uf Bien Shur Preservation Trust (the Trust) comprises a portion of the lands in the Sandia Mountains and near vicinity that are managed by the Cibola National Forest (Figure 7). The lands are held in trust by the Department of Interior for the benefit of Sandia Pueblo, which collaboratively manages the tract with the Forest Service. The Trust was established by the T'uf Bien Shur Preservation Trust Act of 2003, via Bill H.R. 222). The purpose of the creation of the Trust is to recognize the Pueblo's claims to the lands; and to make allowances for traditional and cultural tribal uses of the lands (within the constraints of existing wilderness and wildlife laws), while protecting existing improvements on the lands. The total area of the Trust includes 9,890 acres within the Cibola National Forest, only the easternmost extent of which lies within the Las Huertas watershed (Figure 7).

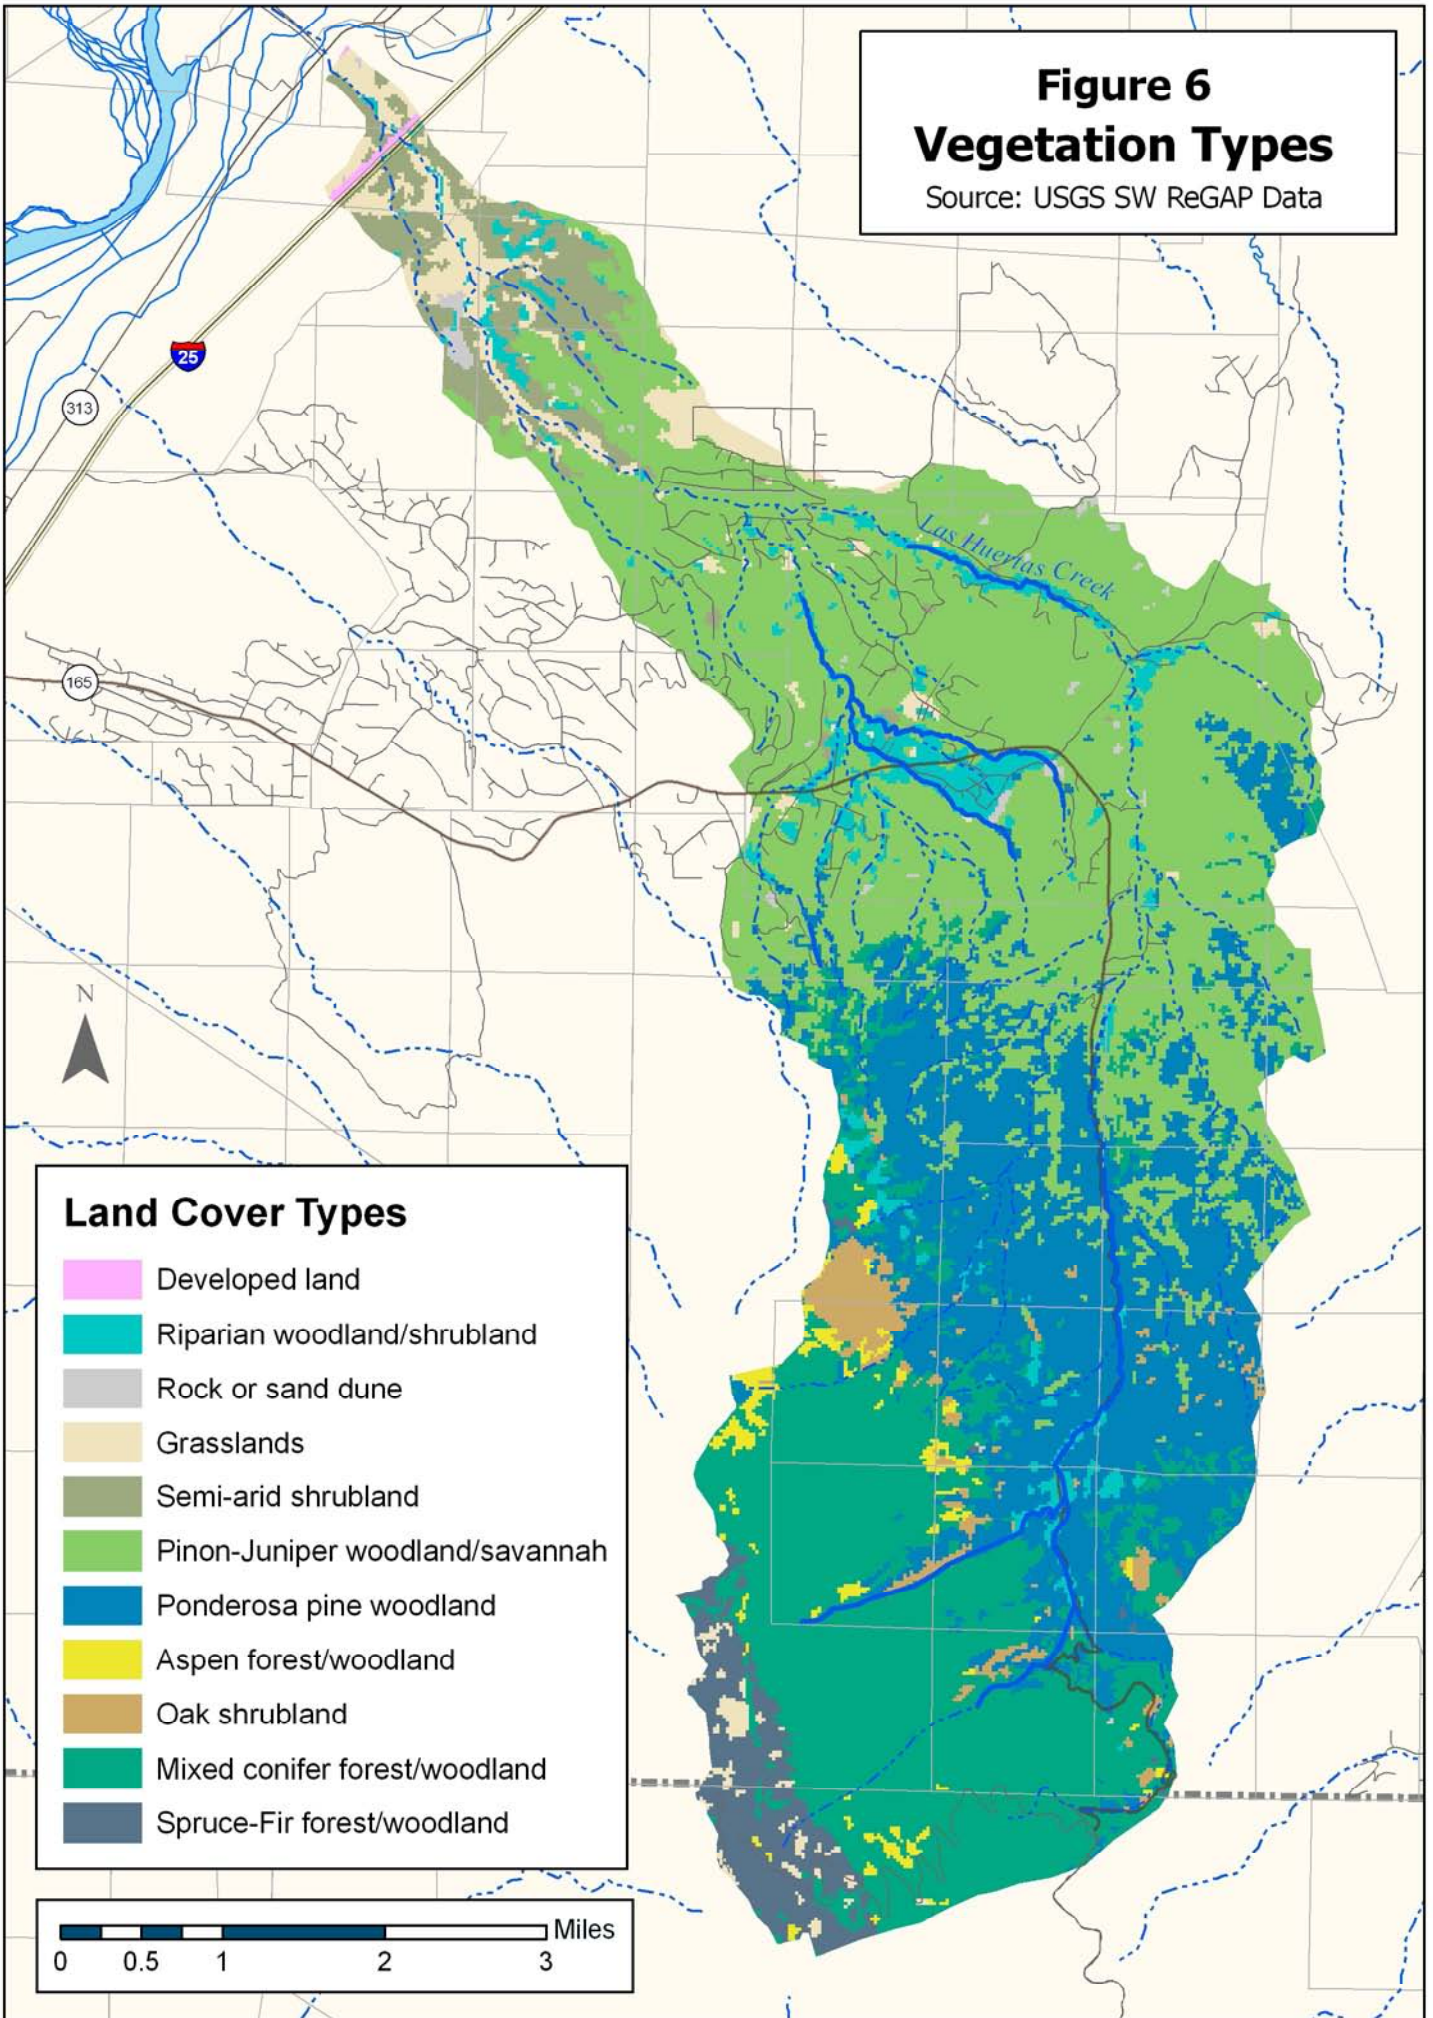
Figure 6 Vegetation Types

Source: USGS SW ReGAP Data

Map by Kristin Willette for Las Placetas Association, June 22, 2005. Map projection and datum: UTM Z13N, NAD83. Primary data source: USGS 2004 'Provisional' SW ReGAP dataset, derived from 30 meter resolution satellite data. See metadata for details.

Vegetation. A simplified schematic of prevailing vegetation types reveals a predominant Pinon-Juniper woodland/savannah vegetation classification in the majority of the lower Las Huertas watershed (Figure 6). Ponderosa pine woodland is the prevailing type in the upper canyon, with mixed conifer forest/woodland the dominant type in the uppermost reaches. Riparian woodland/shrubland characterizes lands adjacent to perennial Creek reaches. A patch of oak shrubland apparent along the western edge of the upper watershed is apparently associated with a burn event in that area. Semi-arid shrubland and grassland predominate in the lowest reach of the watershed traversing I-25. A more detailed analysis of vegetation communities in the lower watershed on the Placitas Open Space may be found in a report by botanist W. Dunmire (Dunmire, 1997).

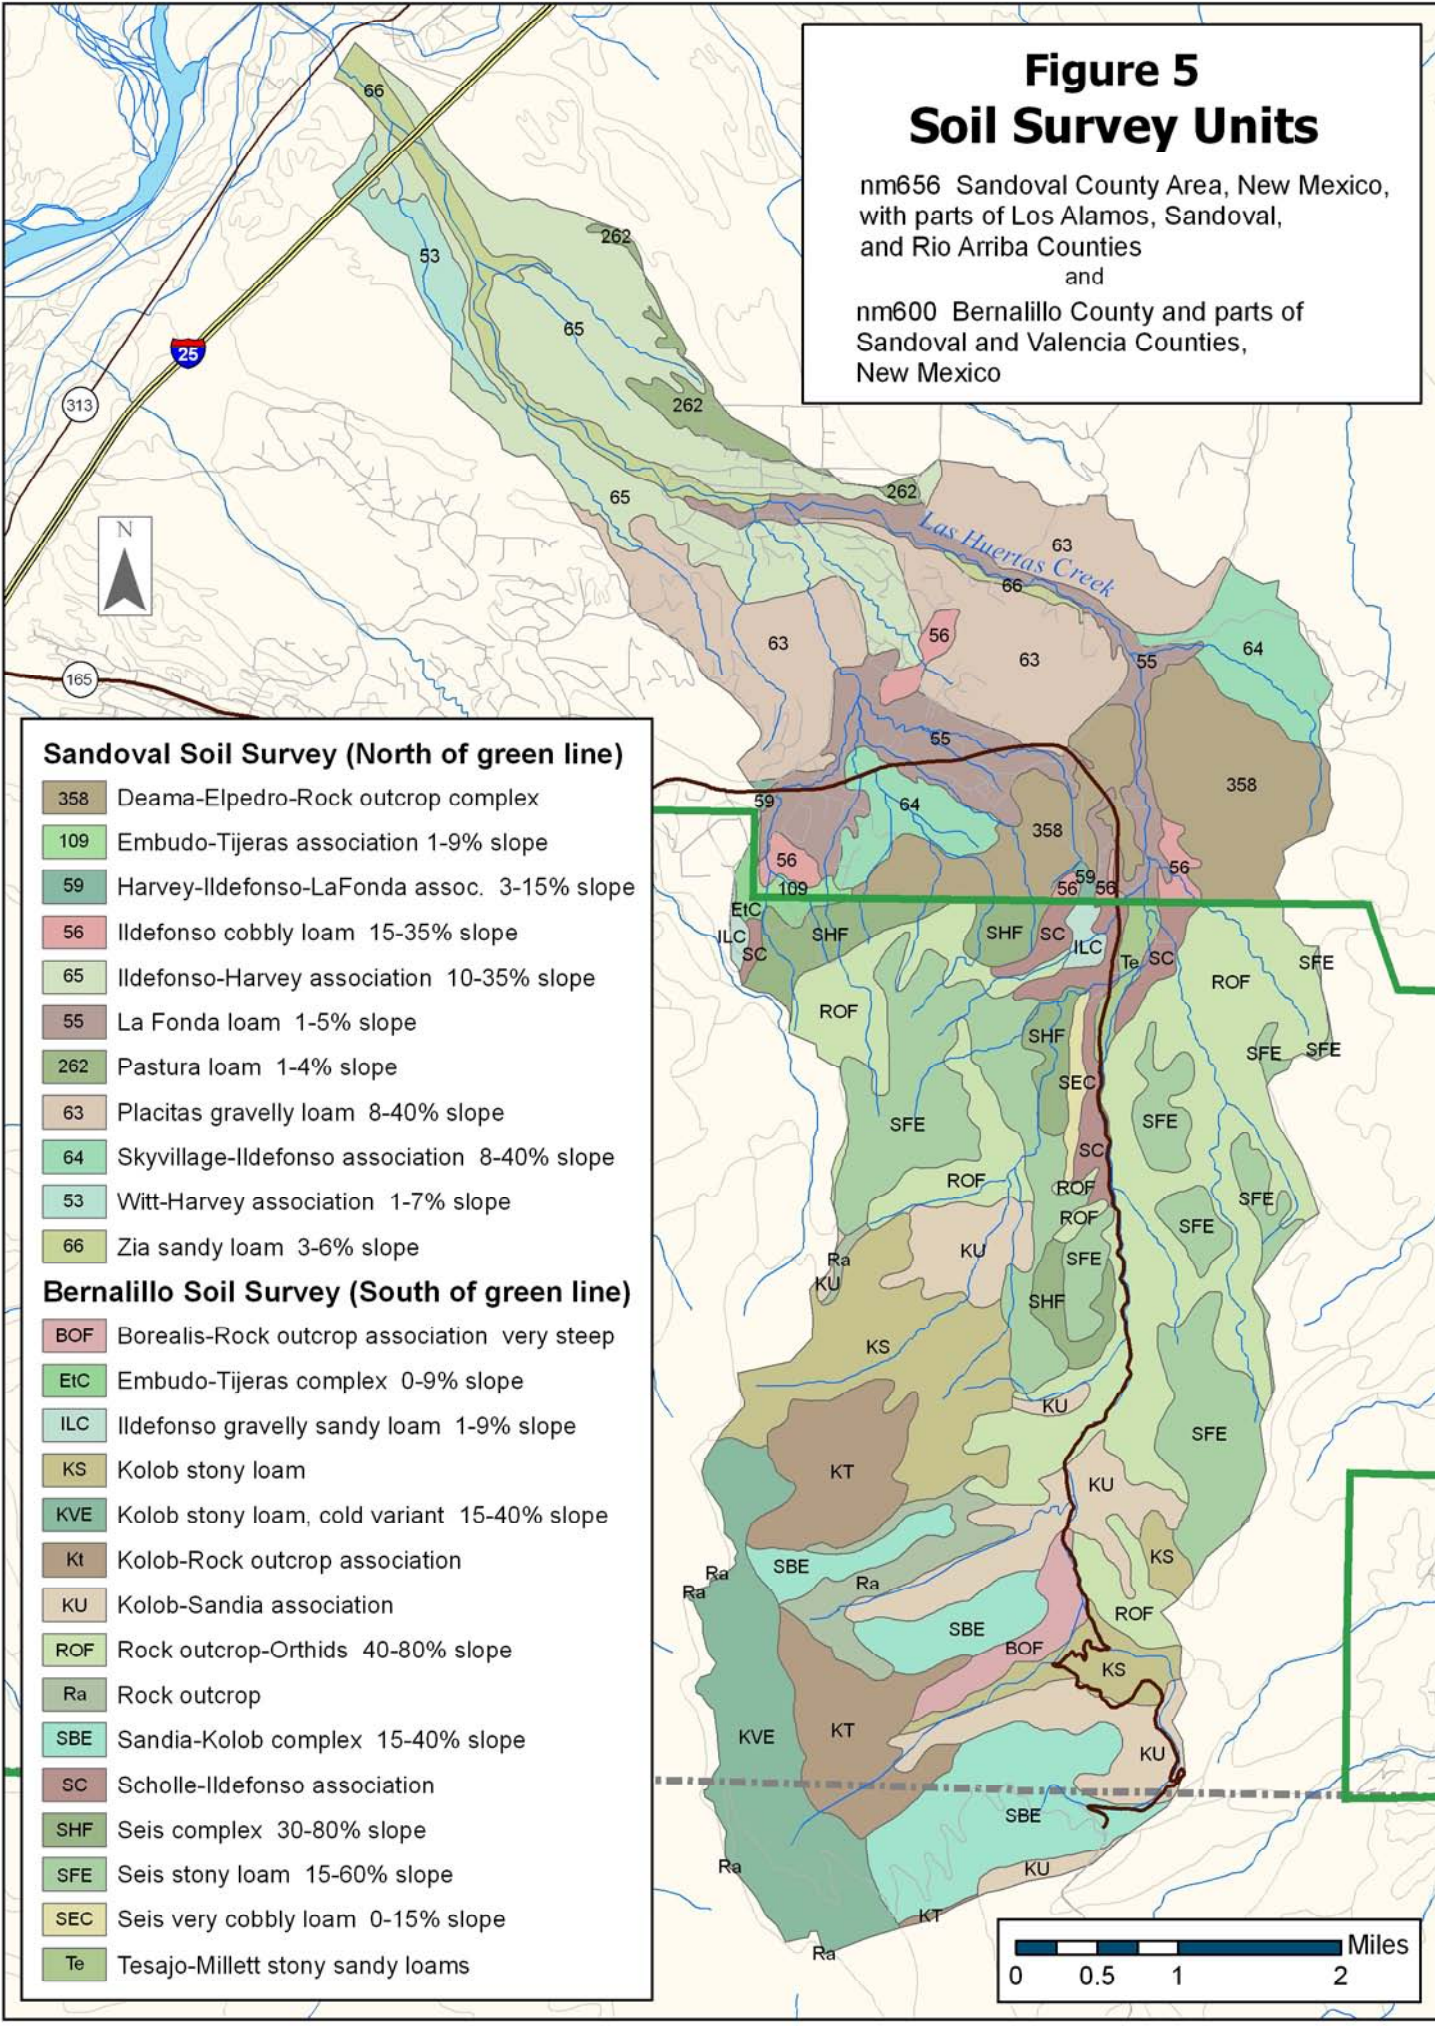
Figure 5 Soil Survey Units

nm656 Sandoval County Area, New Mexico,
with parts of Los Alamos, Sandoval,
and Rio Arriba Counties
and
nm600 Bernalillo County and parts of
Sandoval and Valencia Counties,
New Mexico

Sandoval Soil Survey (North of green line)

- 358 Deama-Elpedro-Rock outcrop complex
- 109 Embudo-Tijeras association 1-9% slope
- 59 Harvey-Ildefonso-LaFonda assoc. 3-15% slope
- 56 Ildefonso cobbly loam 15-35% slope
- 65 Ildefonso-Harvey association 10-35% slope
- 55 La Fonda loam 1-5% slope
- 262 Pastura loam 1-4% slope
- 63 Placitas gravelly loam 8-40% slope
- 64 Skyvillage-Ildefonso association 8-40% slope
- 53 Witt-Harvey association 1-7% slope
- 66 Zia sandy loam 3-6% slope

Soils. Soils distributions in the Las Huertas Watershed were compiled from two separate soil surveys conducted by the Natural Resources Conservation Service (Figure 5). Separate surveys were conducted north and south of the Forest Service boundary in Las Huertas canyon, which resulted in different nomenclature associated with each study. A soil type of La Fonda loam prevails in the bulk of the lower Las Huertas watershed, complemented by Zia sandy loam in the lowermost portion traversing Interstate 25 (Figure 5). Steeper slopes and higher erodibility prevail in the upper portion of the Canyon.

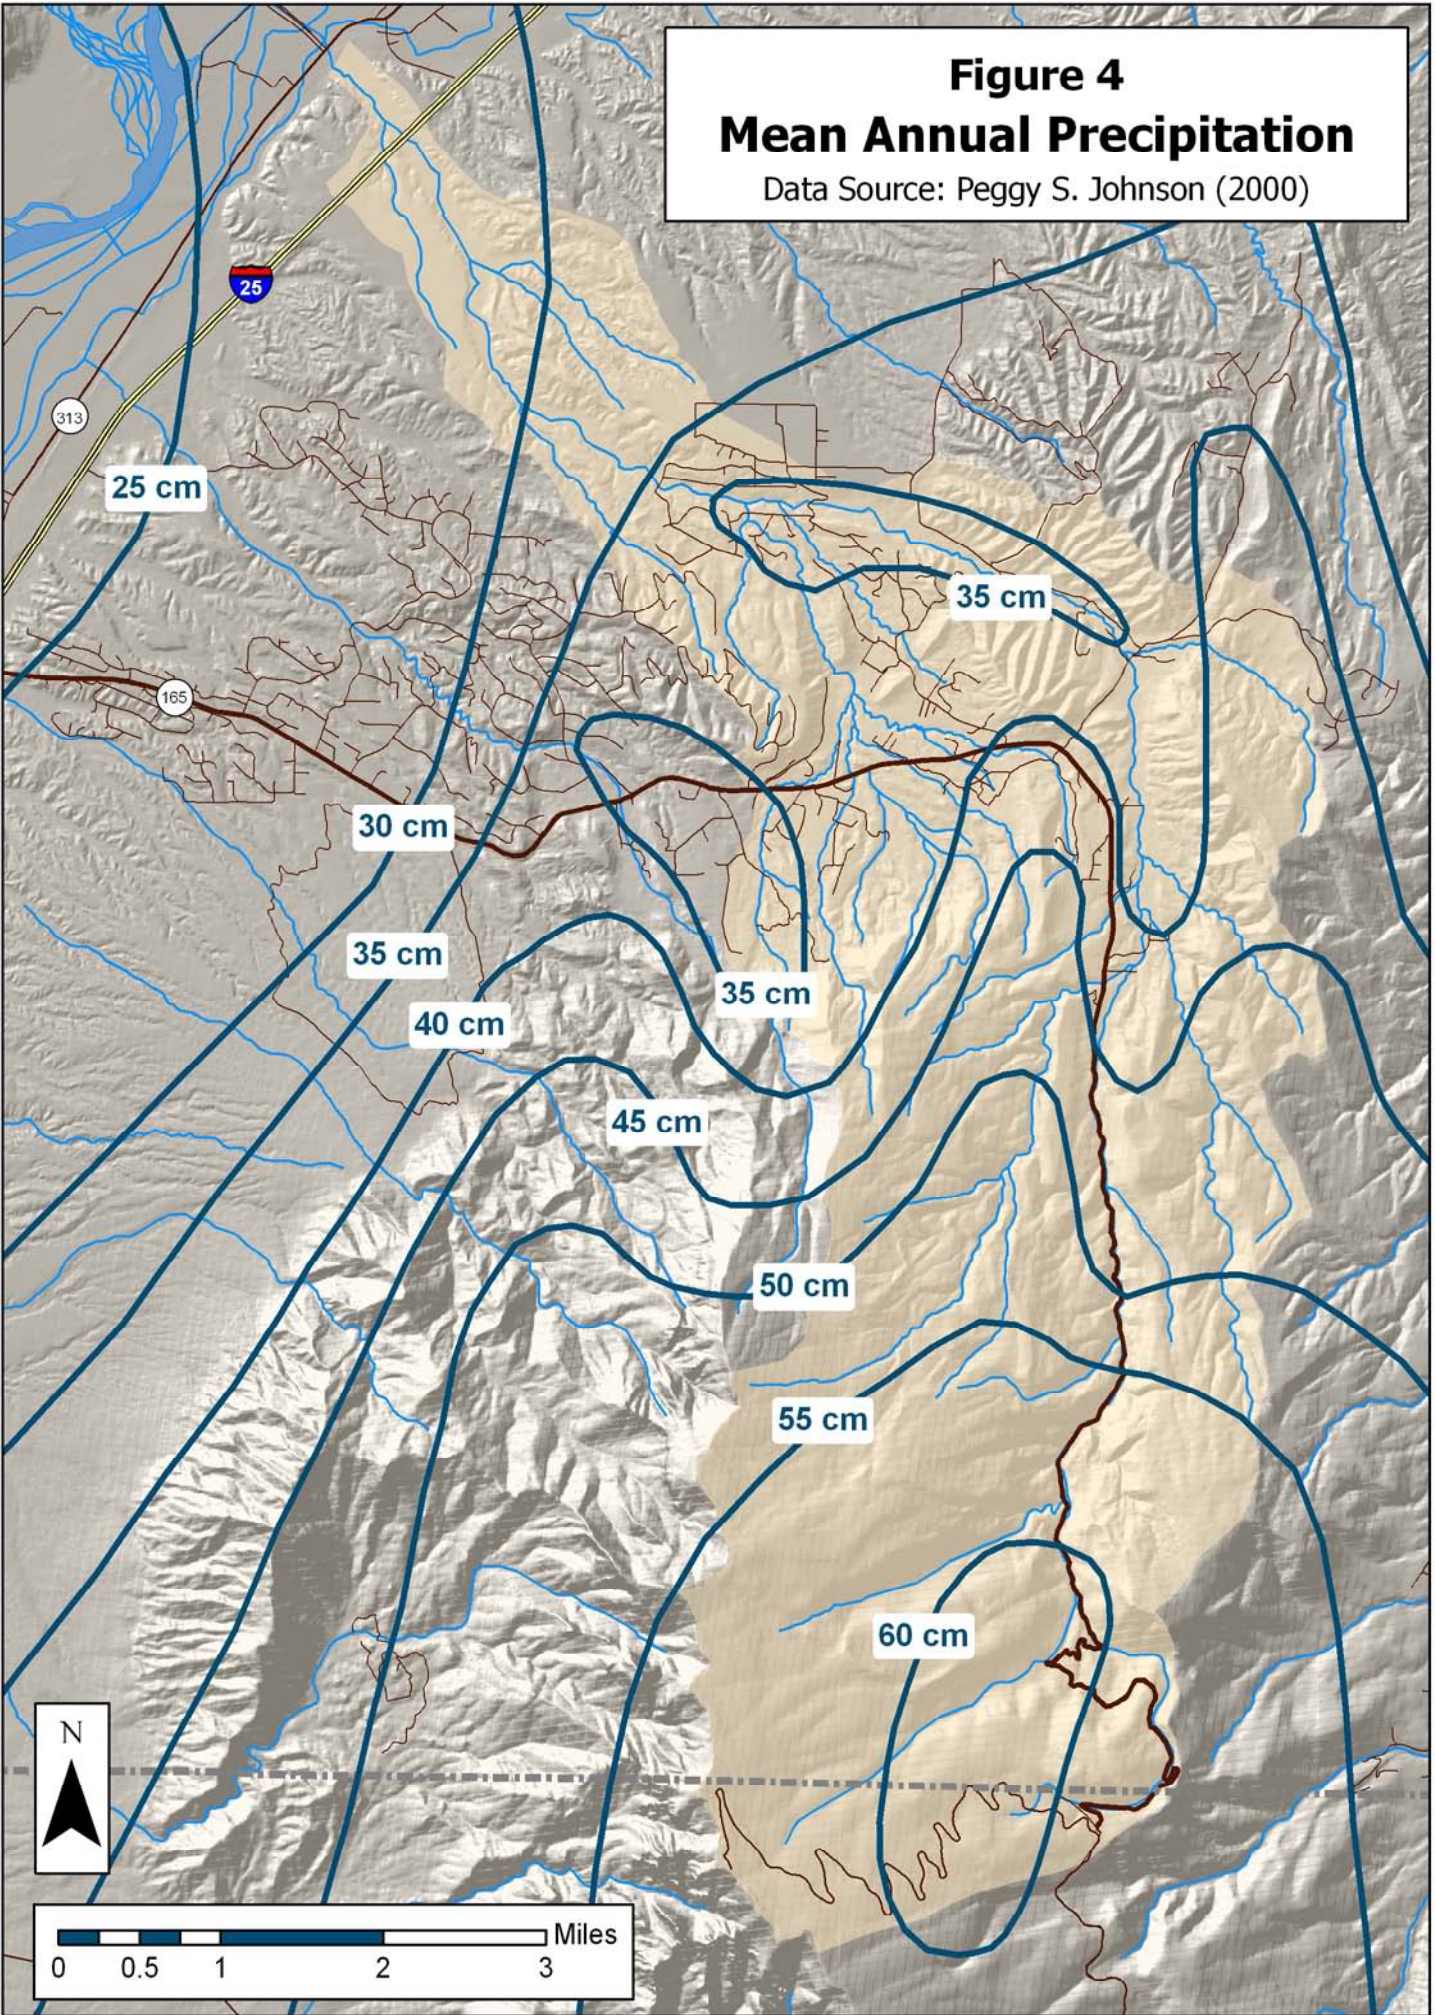
Figure 3 Surface Water Hydrology

Data Source: Peggy S. Johnson (2000)

Map by Kristin Willeite for Las Placitas Association, June 22, 2005. Map projection and datum: UTM Z13N, NAD83. Primary data source: NHBGMR, Peggy S. Johnson (2000). See metadata for base map details.

Surface Water. Las Huertas Creek drains most of the northern end of the Sandia Mountains (Johnson, 2000). The Creek is mostly intermittent, but is perennial through spring-fed reaches in Upper Las Huertas Canyon and below the Rosa de Castilla Spring west of Tecolote (Figure 3). The Arroyo del Ojo del Orno is a large system of tributary drainageways that primarily drains the Mesozoic Ramp hydrologic zone, and is also fed by perennial springs. Arroyo Agua Sarca comprises a separate small (approximately 6 square miles) watershed in the area that drains a section of the west face of the Sandia Mountains, but is not tributary to Las Huertas Creek.

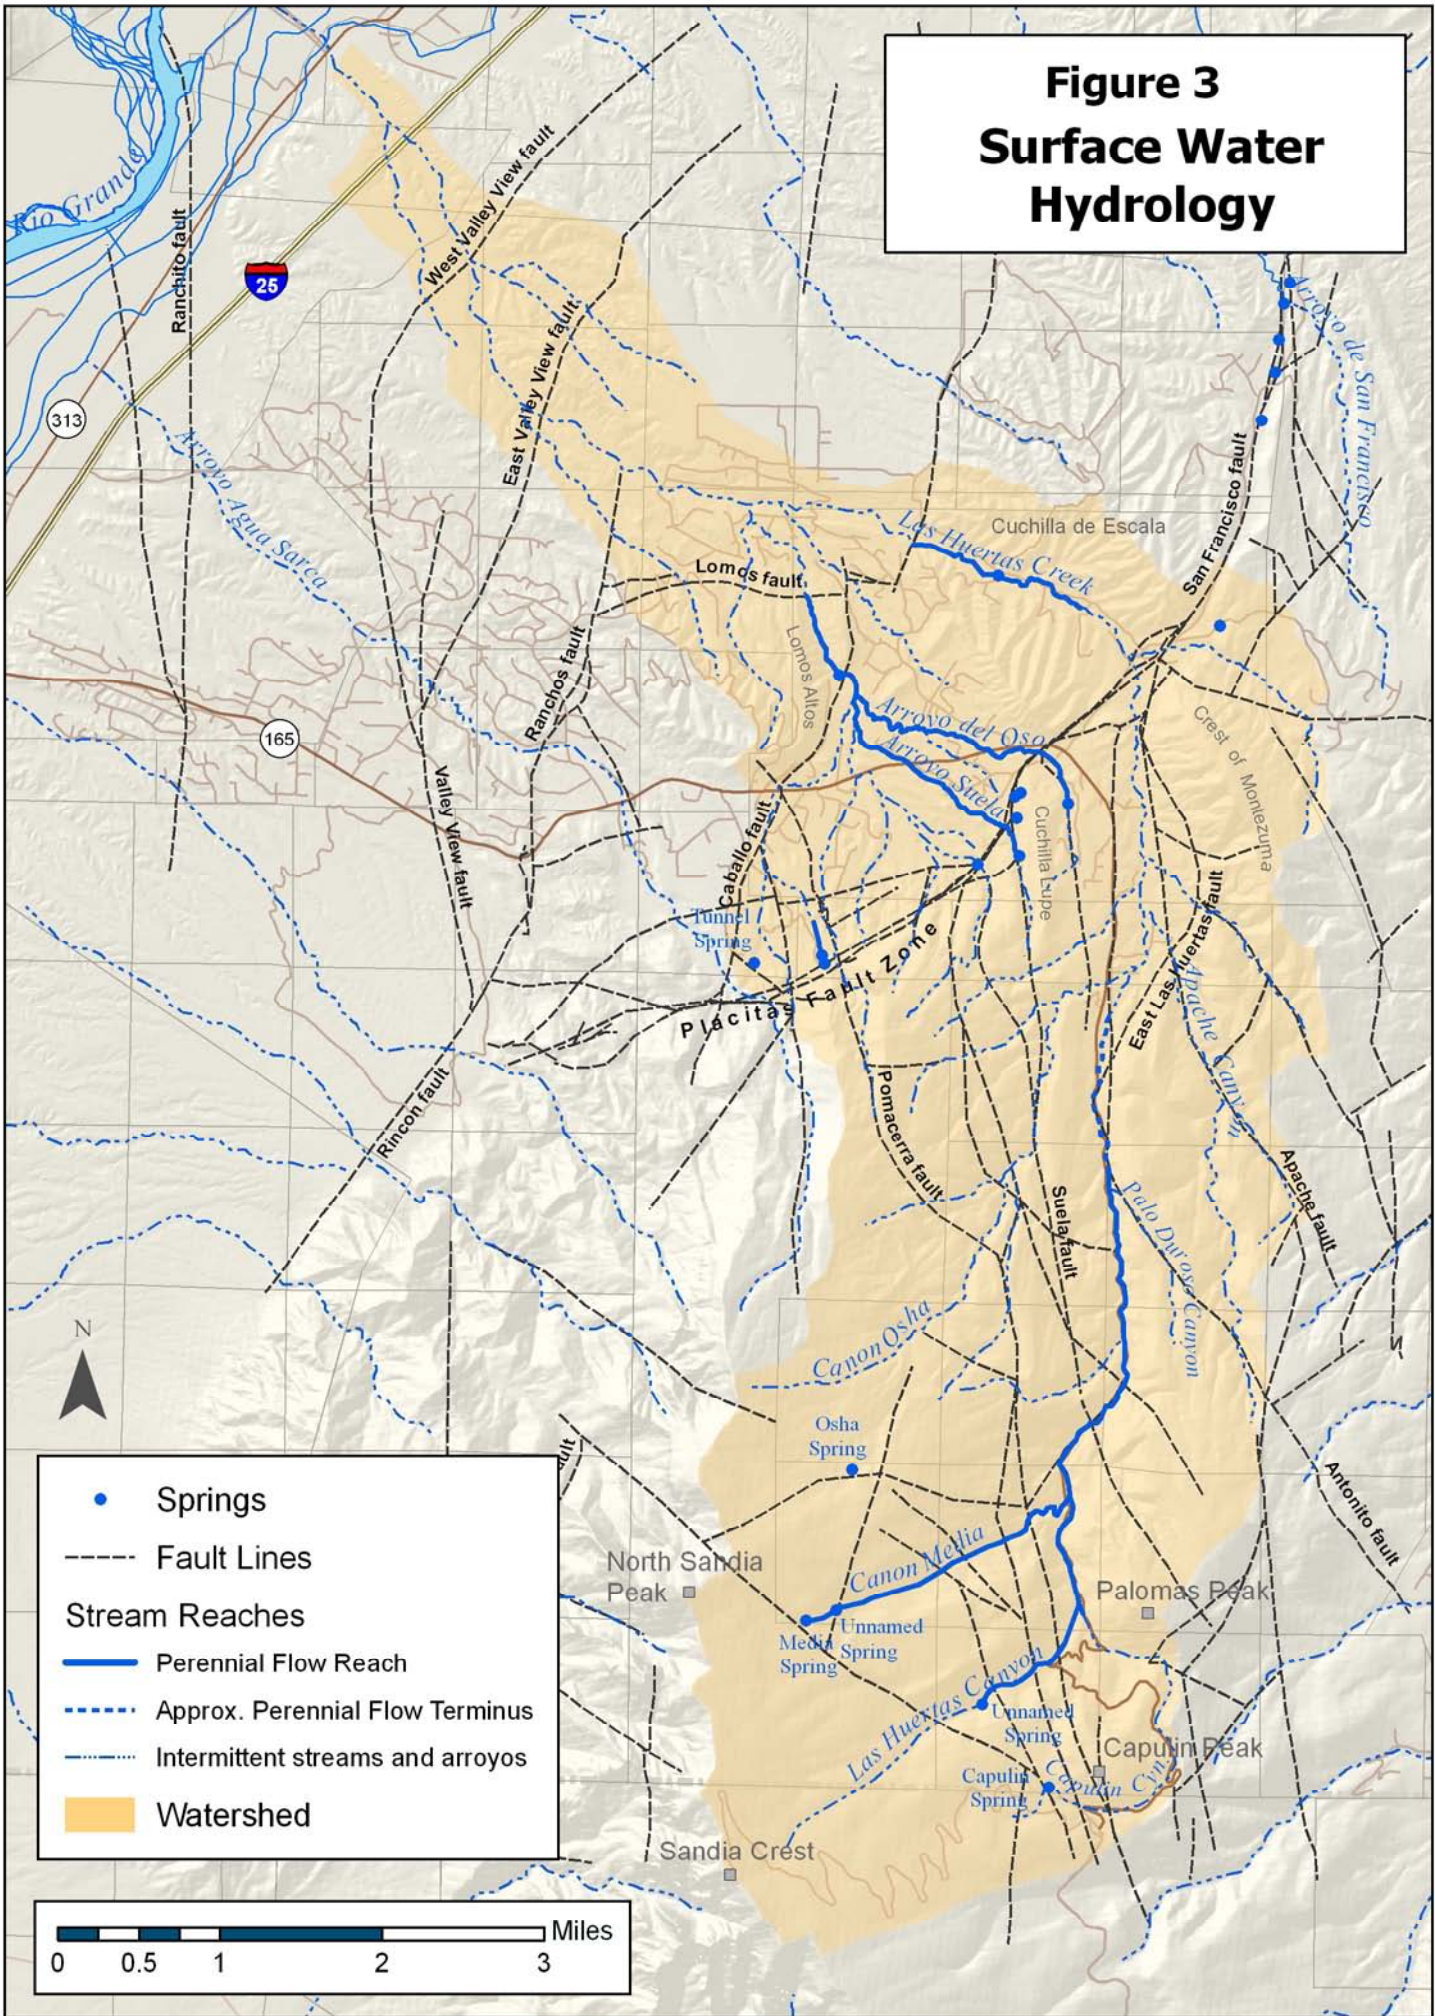
**Figure 2
Geology**

Map by Kristin Willette for Las Placitas Association, June 22, 2005. Map projection and datum: UTM Z13N, NAD83. Primary data sources: Las Placitas Association, NIMBGMIR geology maps, Reid Bandeen, and Peggy S. Johnson (2000). See metadata for details.

Geology/Hydrology. The Las Huertas Creek watershed is comprised of three primary hydrogeologic zones, or hydrologic systems: A). Mountain Zone; B). Mesozoic Ramp; and C). Albuquerque Basin (Johnson, 2000). These hydrologic systems are defined by geologic faults and stratigraphic contacts which hydrogeologic boundaries. Each of these systems is characterized by unique groundwater flow and occurrence and water quality. A generalized geologic map of the watershed study area is provided in Figure 2.

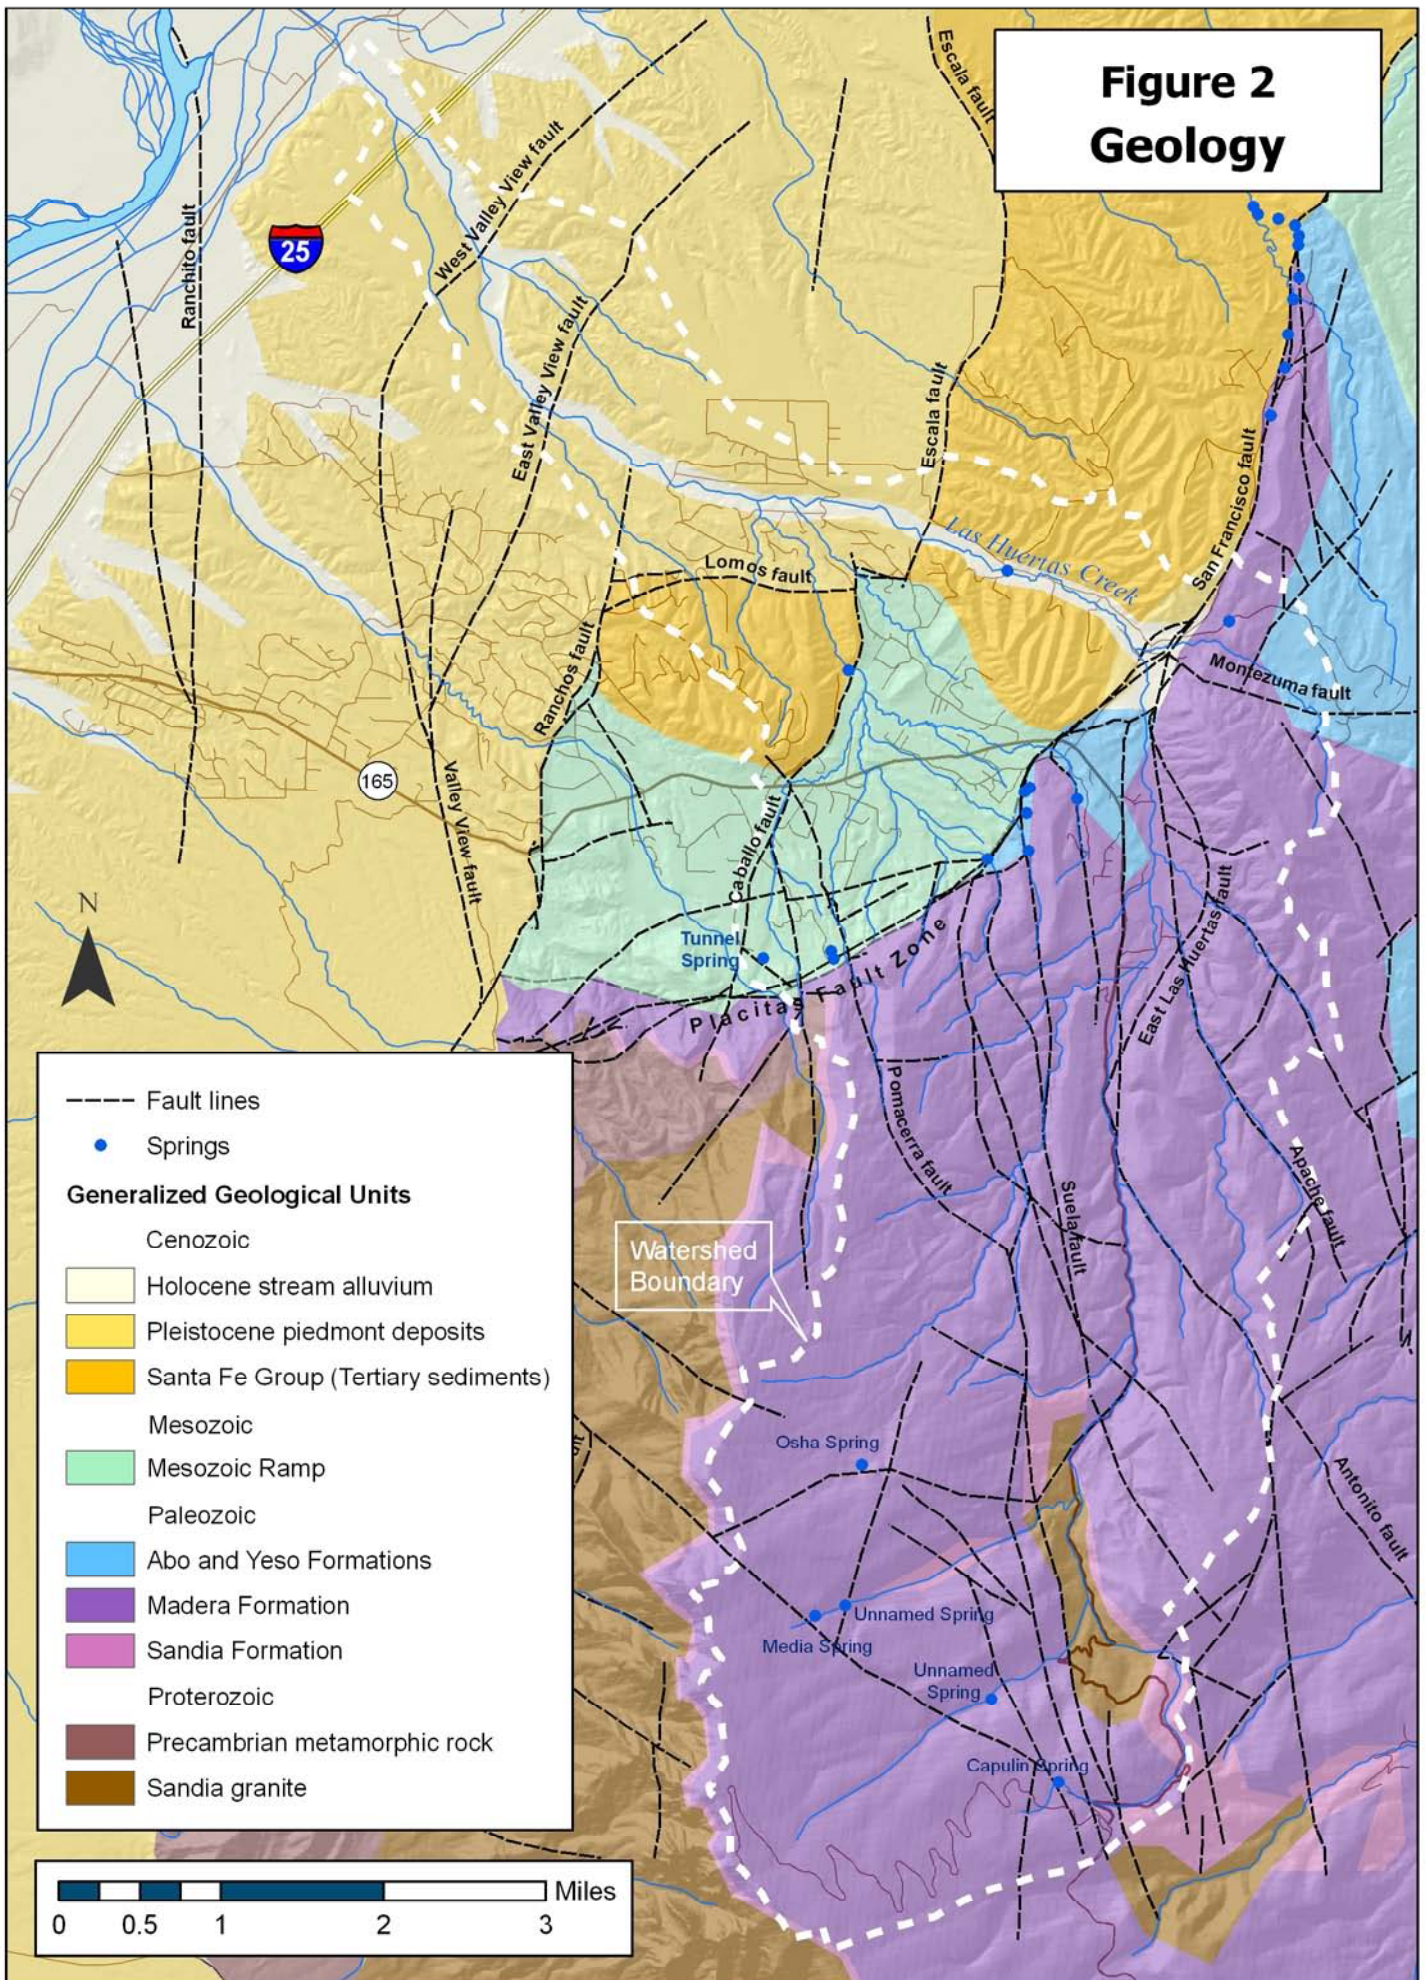
Figure 1 Las Huertas Creek Watershed

Map by Kristin Willette for Las Placitas Association, June 22, 2005. Map projection and datum: UTM Z13N, NAD83. Adapted from an NIBGMR statewide digital dataset intended for 1:500,000 scale, using paper geology maps at 1:24K, 1:48K and 1:500K. See metadata for details.

Contour interval 100 feet

Location. The Las Huertas Creek watershed is located in central New Mexico, mostly in southeastern Sandoval County. The watershed extends approximately to Sandia Crest on the west, to the Sandia Peak ski area to the south, includes the subwatersheds of Palo Duro, Apache and Perdiz Canyons on the east. The watershed's northern boundary generally occurs within a mile of the channel of Las Huertas Creek or its northerly tributary arroyos (Figure 1). The headwaters begin in the northerly portion of the Sandia Mountains, flow north to and through the village of Placitas and then head northwest under Interstate 25 and west to meet the Rio Grande near the town of Bernalillo. The watershed is approximately 19,704 acres in area, and the Creek is approximately 16 miles in length from the source to where it joins the Rio Grande north of the town of Bernalillo (Figure 1). Las Huertas Creek is in the Rio Grande-Santa Fe watershed U.S. Geological Survey (USGS) Hydrologic Unit Code (HUC) 13020201.
